Review Draft 2.29.12
Rehabilitation Study
Old Town Hall
Sterling, Massachusetts

EXECUTIVE SUMMARY

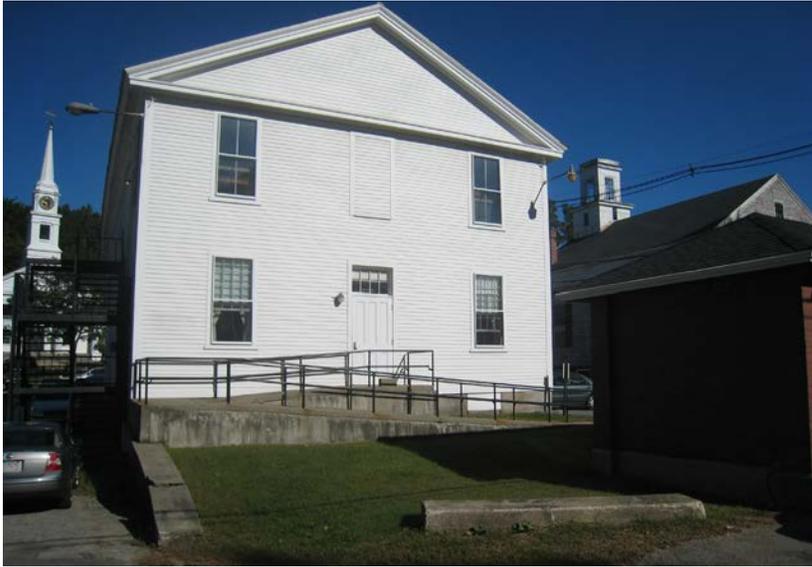
South elevation.

The south (rear) elevation, which is three bays wide, has a centered single entry with transom. The central window at the second floor, located behind the stage in the assembly room, was filled in. A concrete handicap access ramp with metal hand railings spans the width of the building.

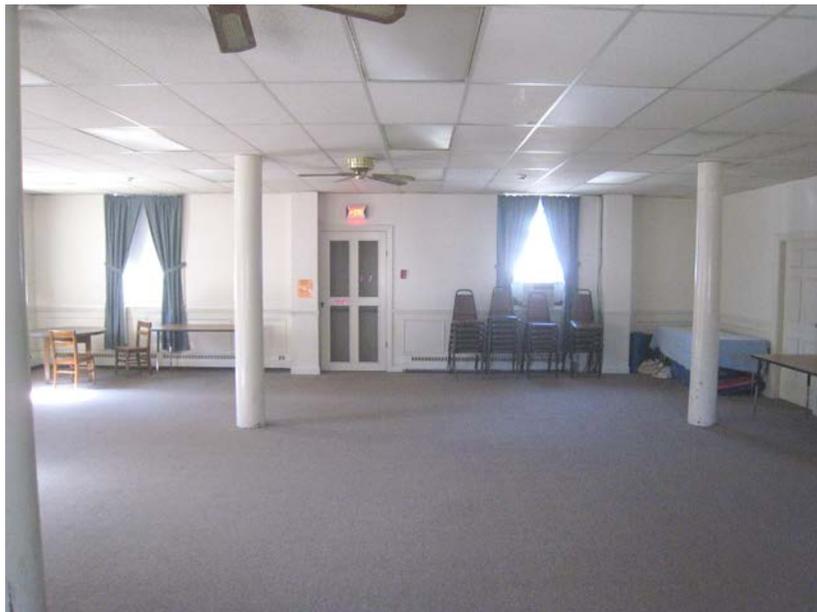
First floor: View south toward exit door in Recreation Room. Note wood columns from the 1893 addition which help support the large Assembly Room, carpeting and dropped ceiling.

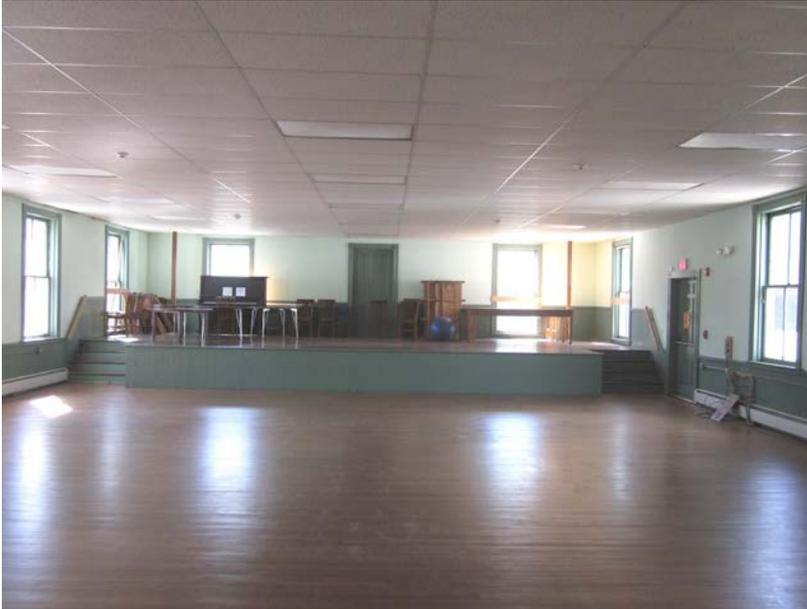
Second floor: Stage at south end of the Assembly Room. The rear window was blocked in when the stage was installed. The egress door at right was converted from a window when the fire escape was installed.
