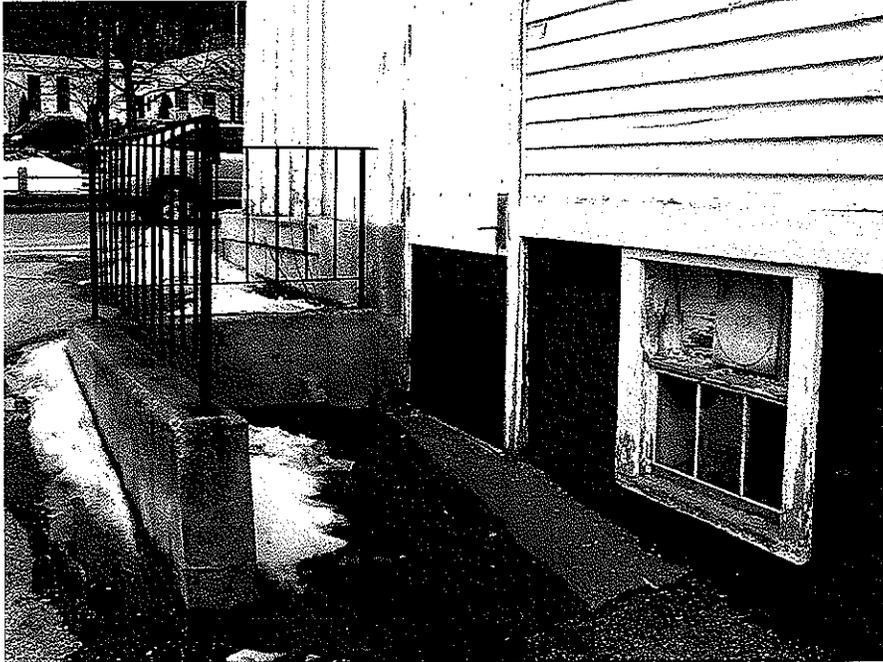
STAIR EXIT DOOR AND AREAWAY

- Door Boarded Up and Steel Plate Added
- Cracked Concrete Wall
- Rusting Metal Railing
- Broken Basement Window Boarded Up
- Brick Missing Upper Right of window Opening

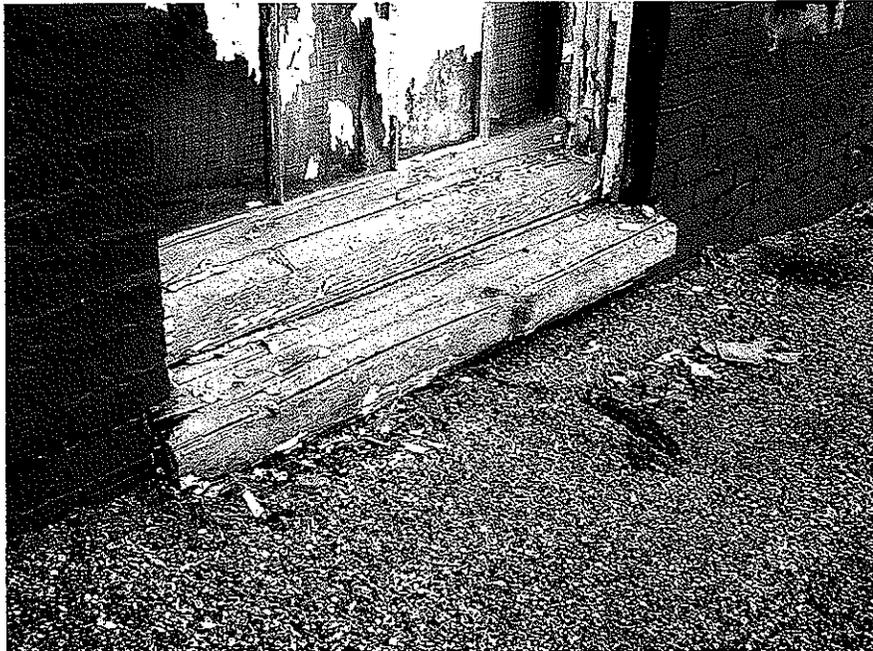
BASEMENT WINDOW SOUTH ELEVATION

- Rotted Wood Window Sill
- Paint Failure at Window
- Broken / Missing Glazing Putty

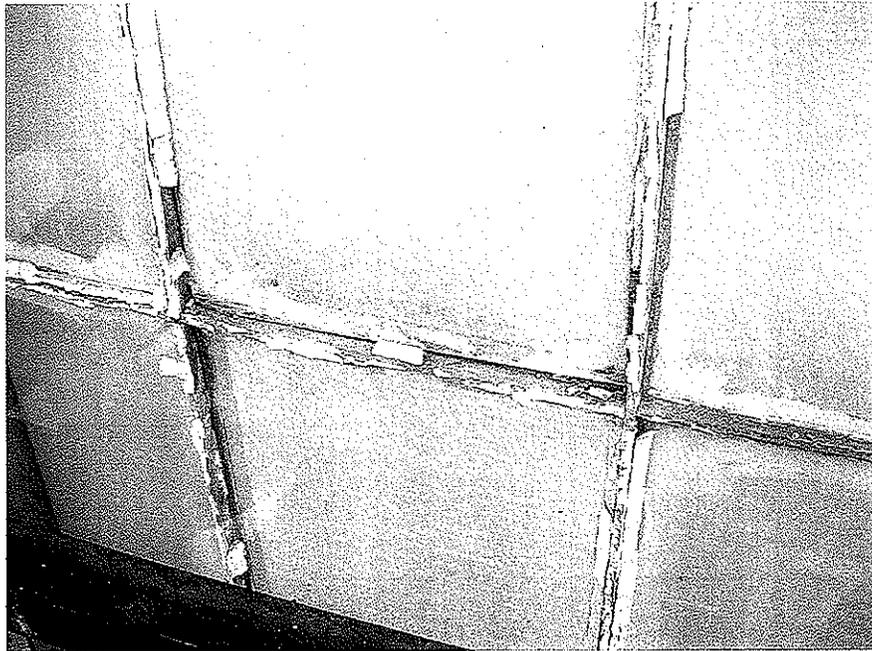
FIRST FLOOR WINDOW SOUTH ELEVATION
• Broken / Missing Glazing Putty

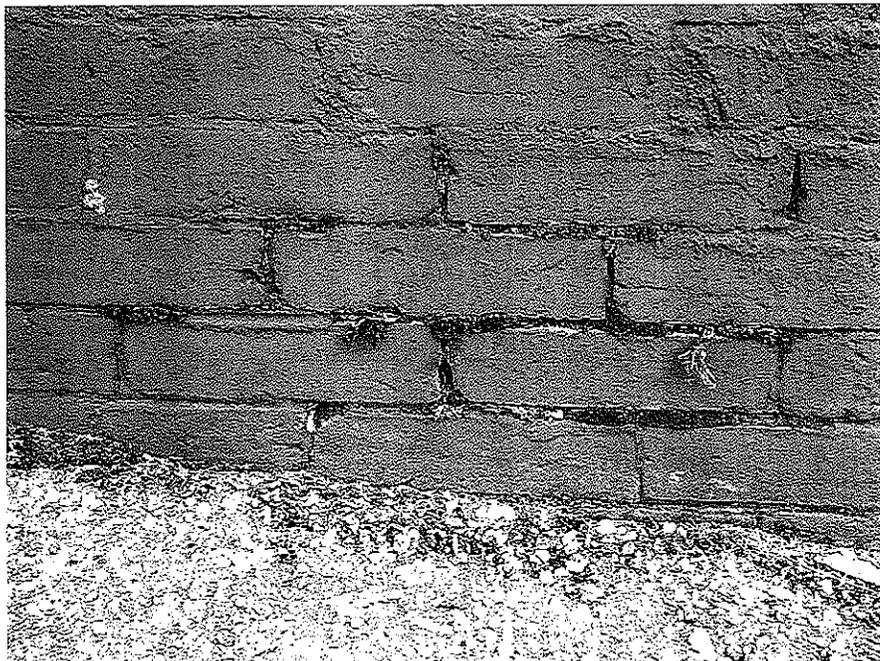
FIRST FLOOR WINDOW SOUTH ELEVATION
• Moss Growing in Mortar Joints

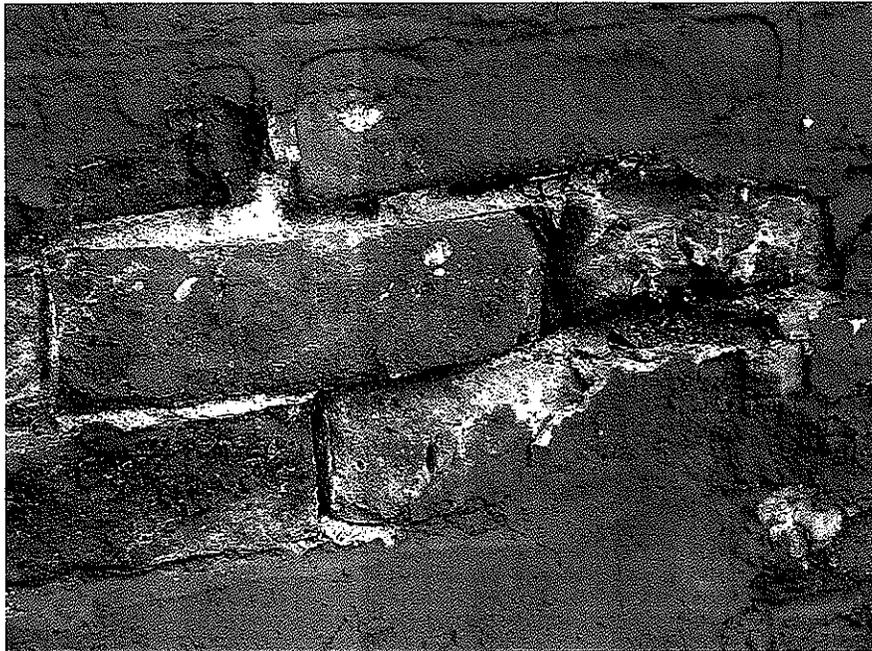
BRICK FOUNDATION SOUTH ELEVATION

- Spalled Deteriorated Brick
- Deteriorated / Missing Mortar

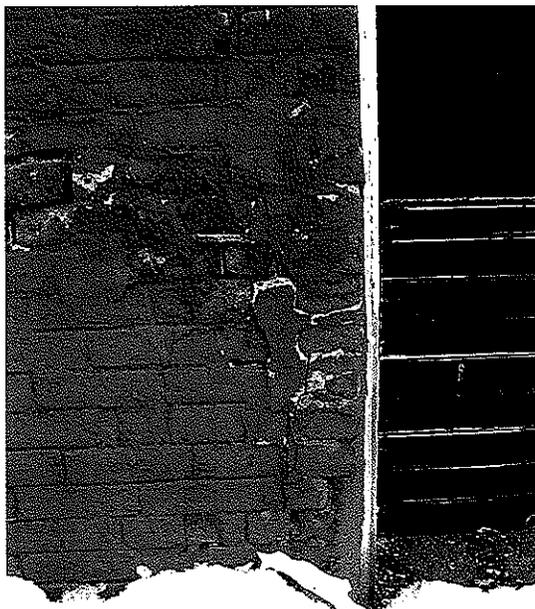
BRICK FOUNDATION SOUTH ELEVATION

- Broken Previously Repaired Masonry Jamb
- Cracked Broken Masonry
- Deteriorated / Missing Mortar
- Typical of (2) Doors

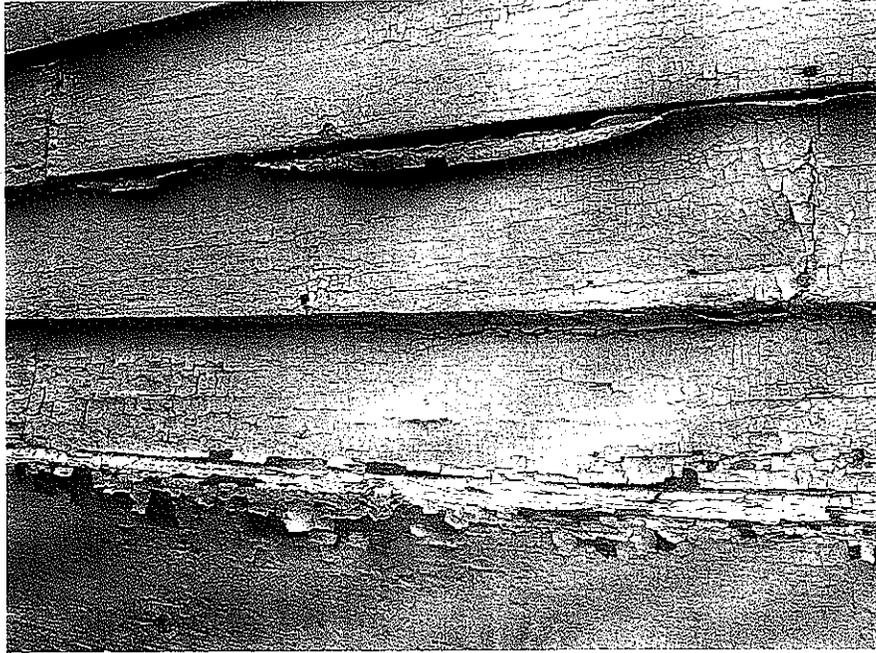
WOOD SIDING SOUTH ELEVATION

- Cracked, Crazed, Peeling, Curling Paint Failure

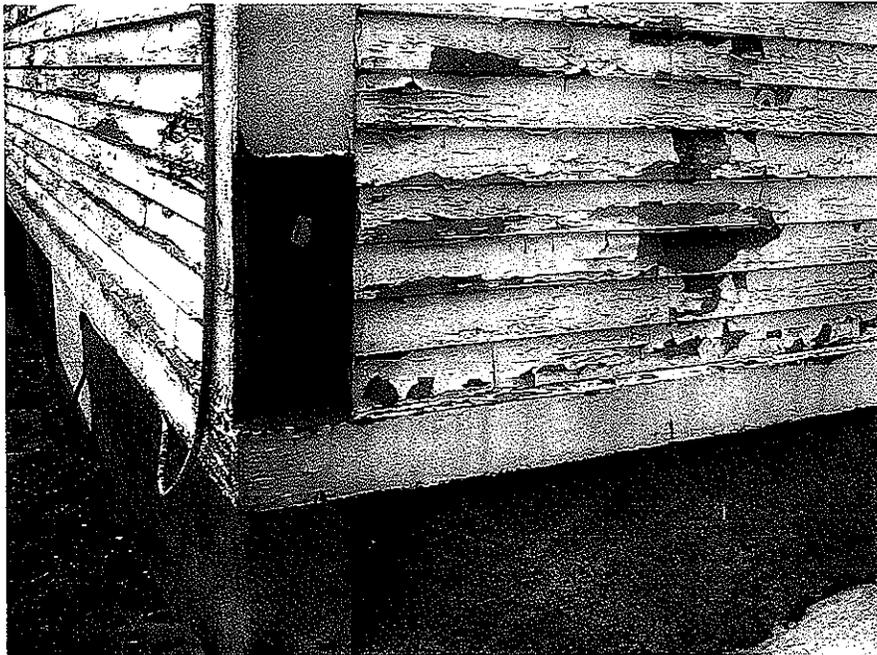
WOOD CORNERBOARD / SIDING NORTHEAST BUILDING CORNER

- Paint Failure at Clapboard Siding
- Missing Cornerboard Trim

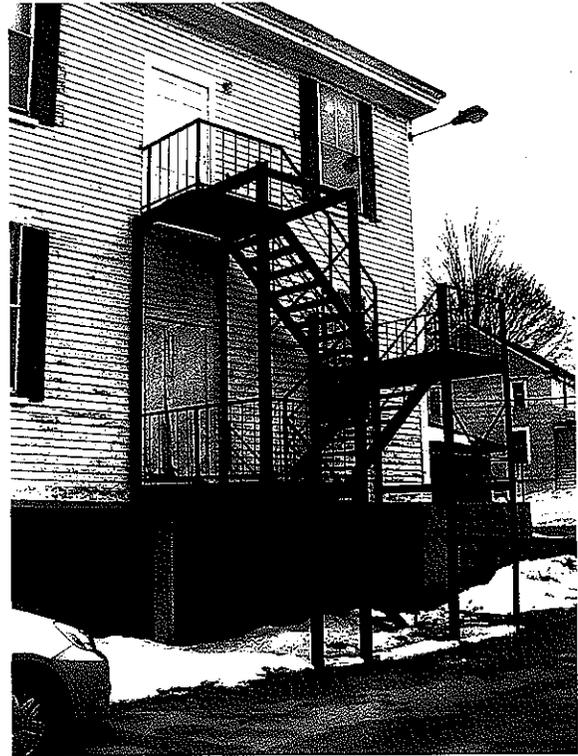
STEEL FIRE ESCAPE

- Steel Supports in Contact with Ground
- First Floor Door Boarded Up
- Non-Historical Light Fixtures

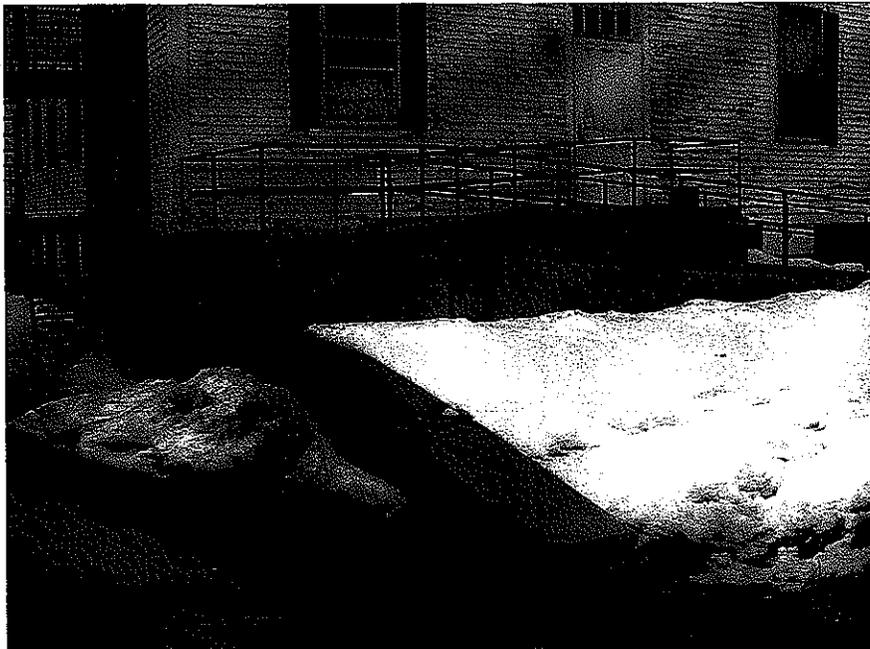
STONE / CONCRETE RETAINING WALL

- Broken Concrete
- Exposed Reinforcing Bar
- Loose / Broken Stone Mortar Joints

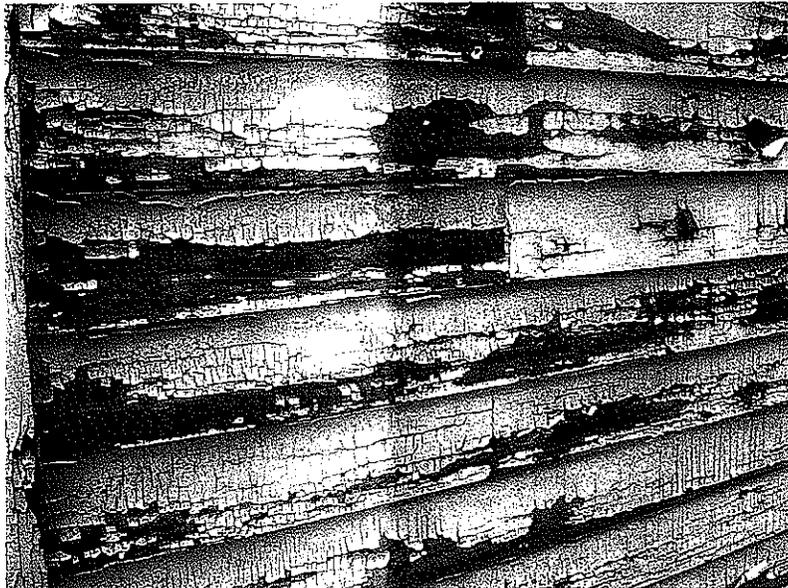
WOOD SIDING NORTH ELEVATION

- Cracked, Crazed, Peeling, Curling Paint Failure

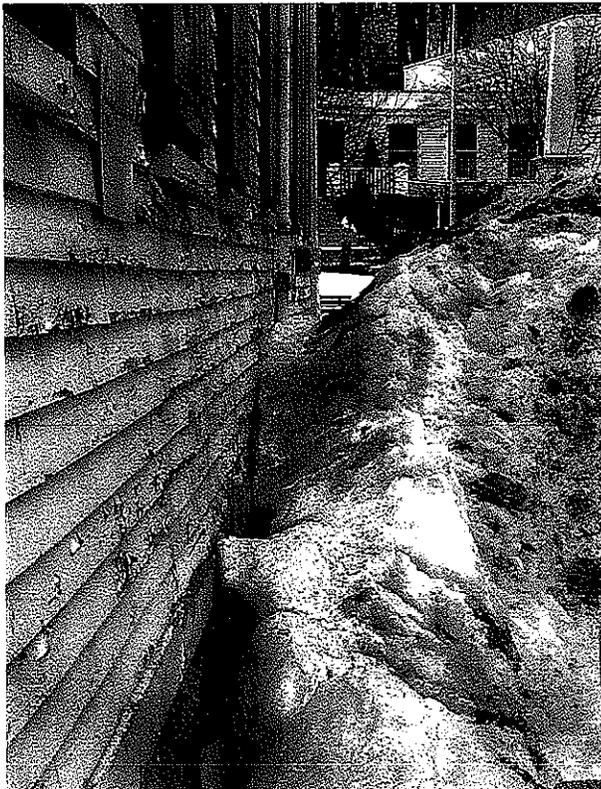
NORTH ELEVATION SNOW PILE

- Snow Pile Obstructing Electric Meter
- Snow Pile Obstructing Boiler Air Intake

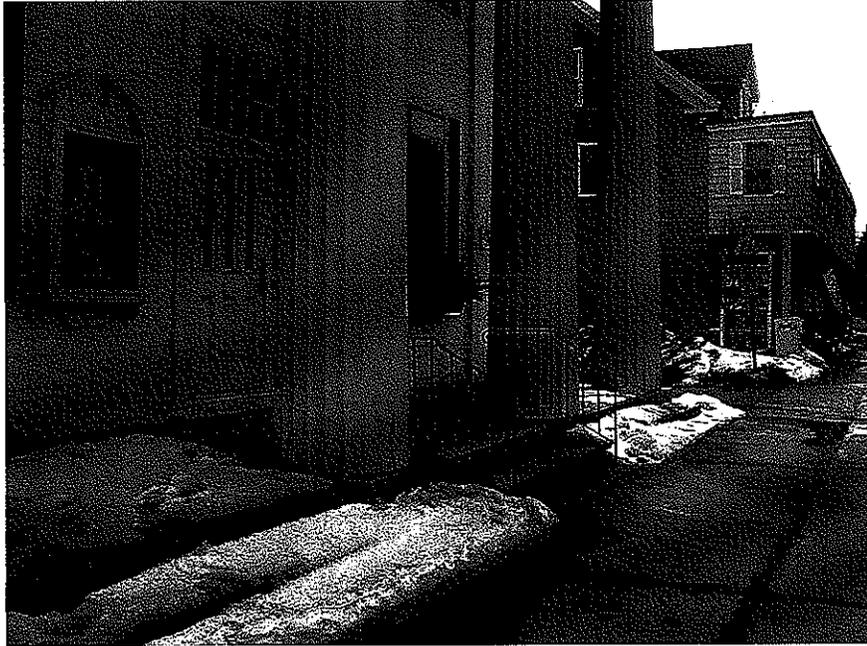
MAIN ENTRANCE PORTICO

- Recess Granite Below Columns

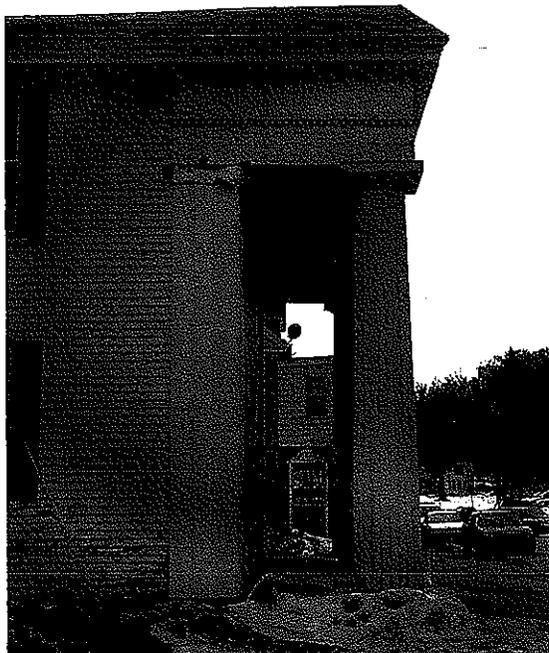
NORTH PORTICO ELEVATION

- On-Going Corner Capital Repairs

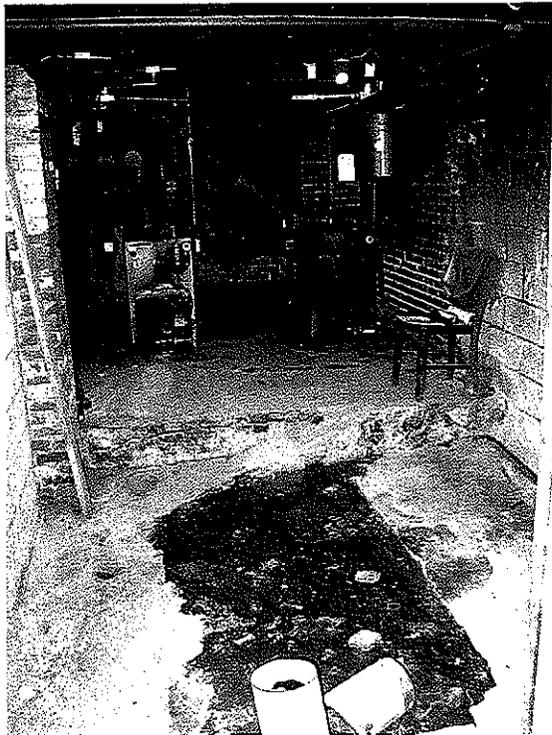
BASEMENT BOILER ROOM

- Open Concrete Floor Slab

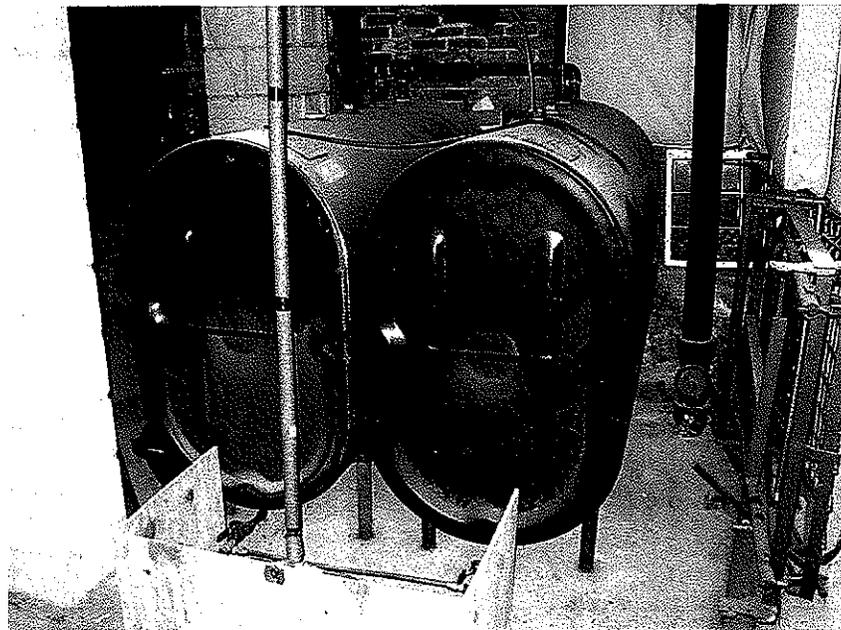
BASEMENT FUEL OIL TANKS

- Plywood Protection Skirt at Exposed Piping and Valves
- Existing Sewer Entrance
- Newer CMU Structural Piers (Left)
- Mattress to Block Basement Window Opening (Upper Right)

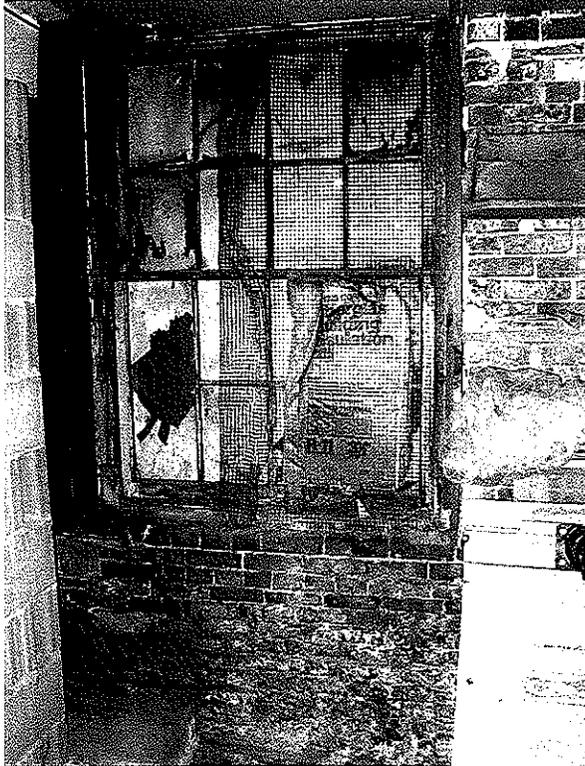
BASEMENT WINDOW

- Broken, Deteriorated Wood Window
- Moisture Damage at Masonry below Window

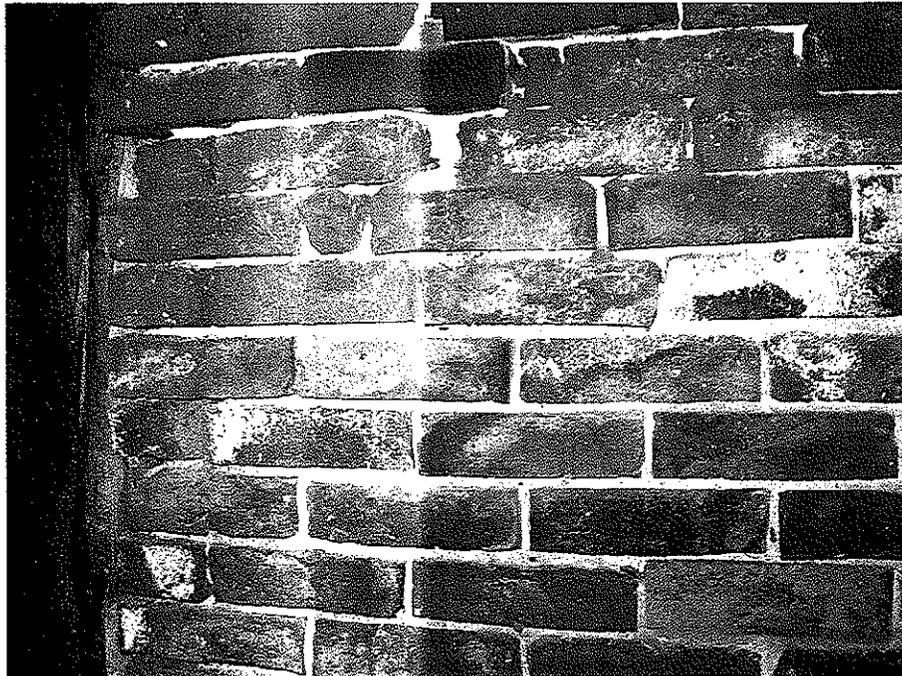
BASEMENT BRICK INTERIOR BEARING WALL

- Deteriorated and Missing Mortar

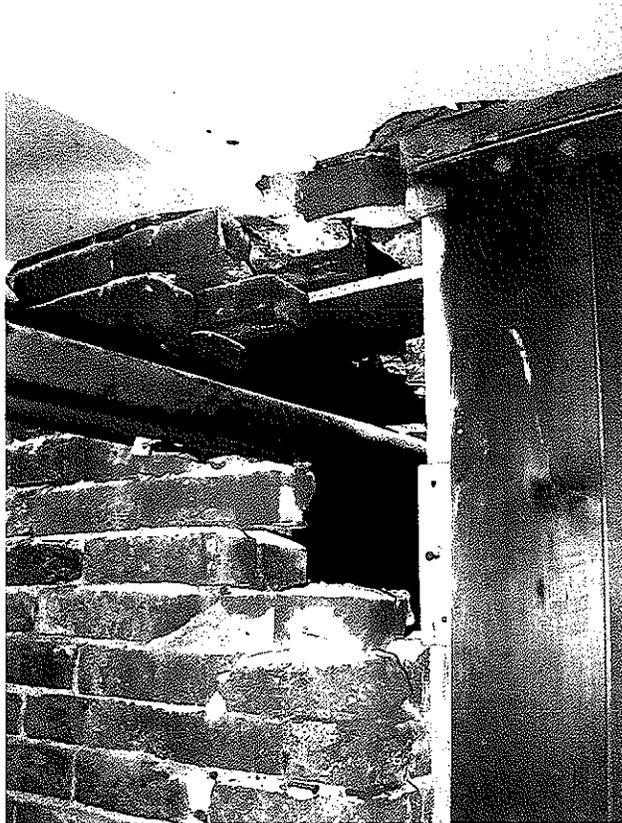
BASEMENT BEARING WALL

- Brick Removed for Pipe Installation
- Missing / Deteriorated Mortar

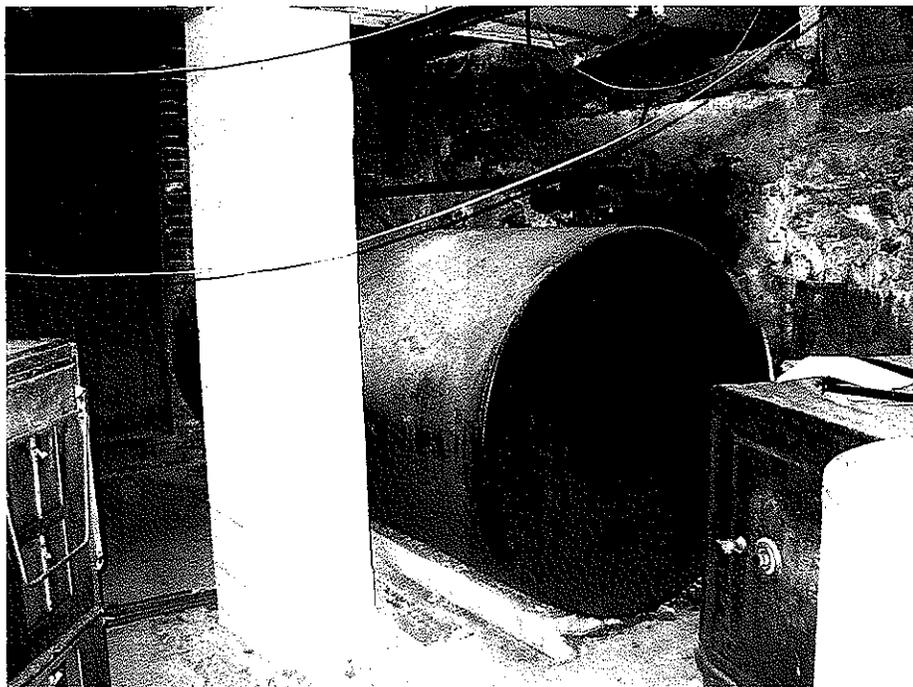
BASEMENT ABANDONED FUEL OIL TANK

- CMU Supplemental Pier
- Rubble Stone Foundation Intact

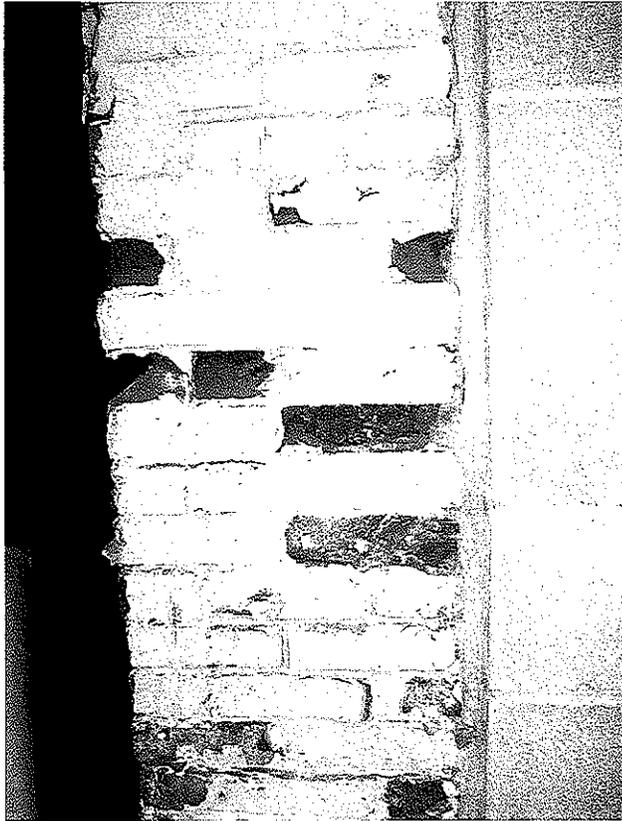
BASEMENT COLUMN REPAIR

- Deteriorated Brick Pier
- Supplemental CMU Pier

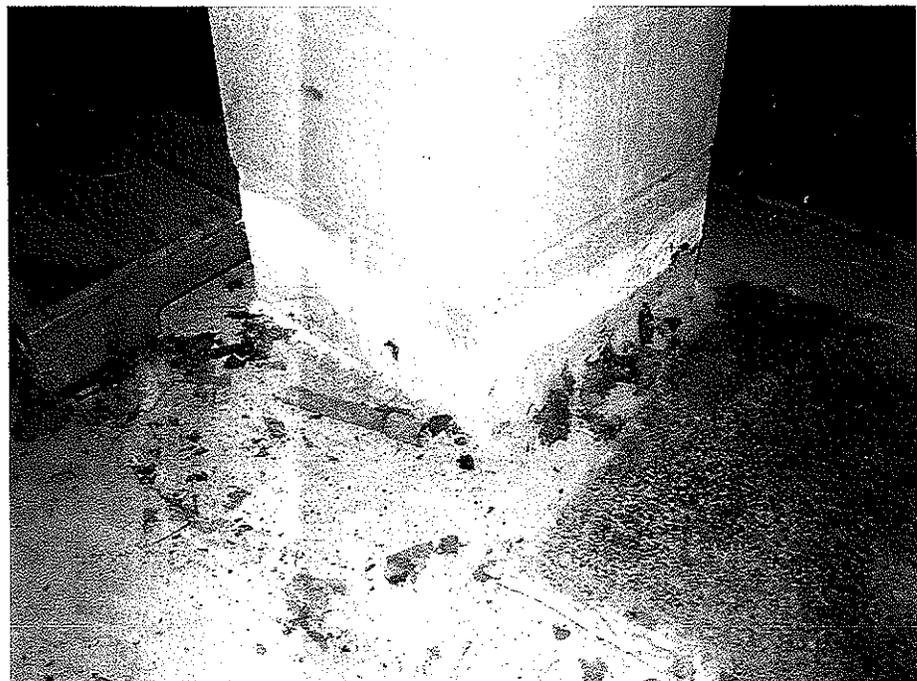
BASEMENT COLUMN REPAIR

- Supplemental CMU Pier
- Efflorescent Staining from Previous High Water

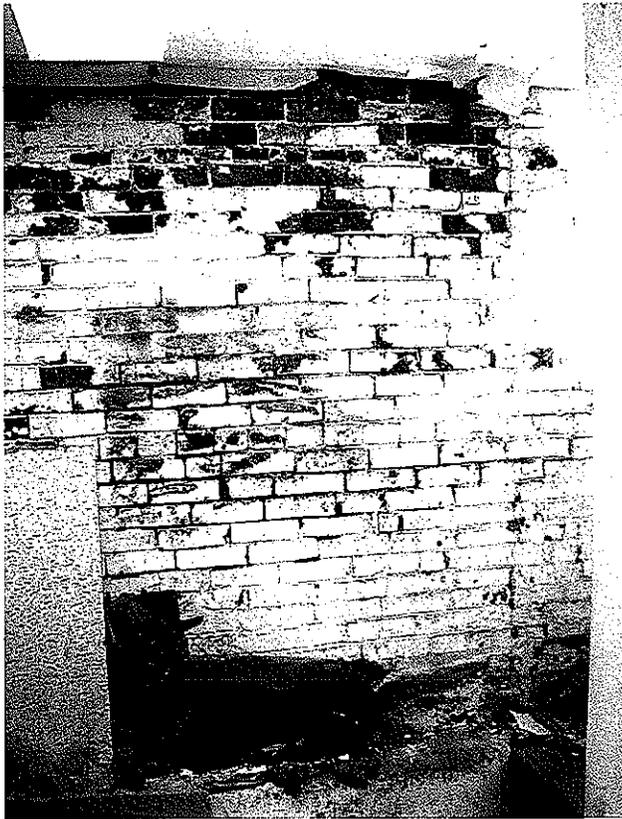
FOUNDATION WALL AT BASEMENT STAIR

- Missing and Deteriorated Mortar Joints
- Missing, Flaking Paint

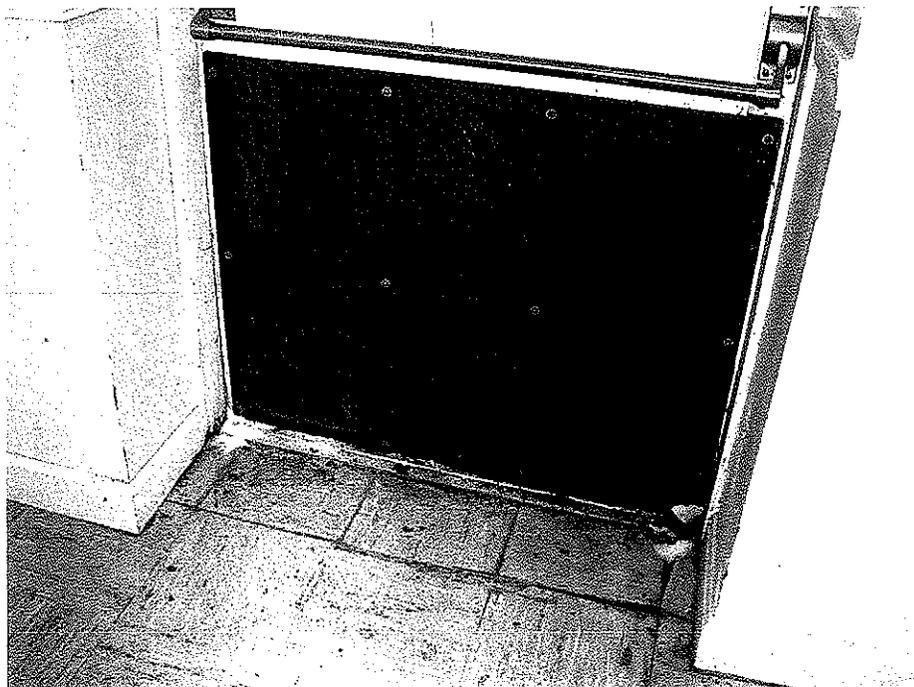
STAIR EXIT DOOR

- Plywood Covered Door
- Rusting Steel Plate Reinforcing
- Moisture Damage. Buckling Vinyl Tile

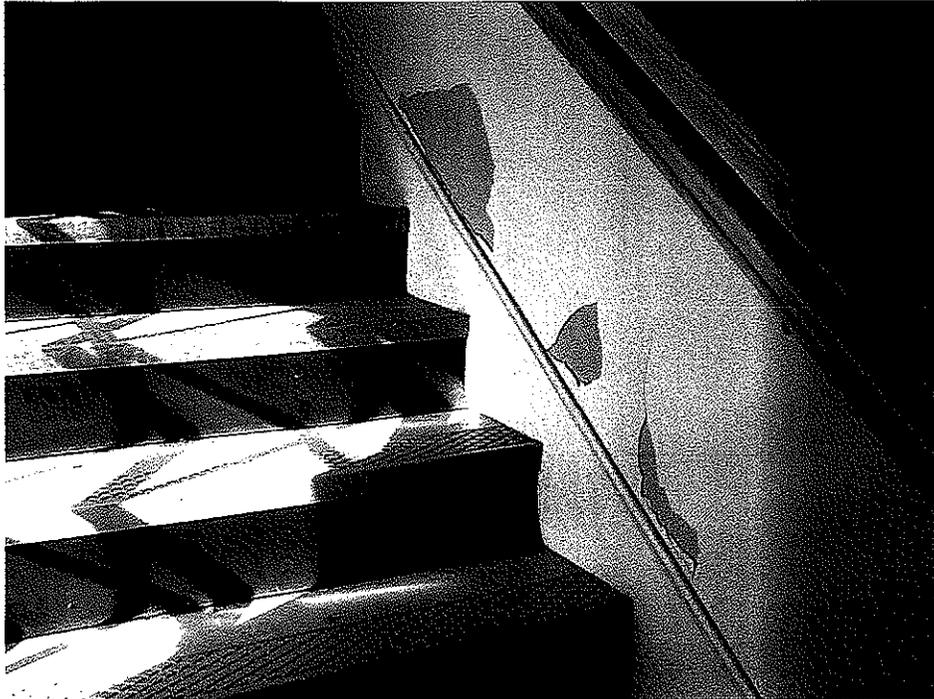
EXIT STAIR

- Loose, Spalling Paint
- Vinyl Stair Treads and Risers

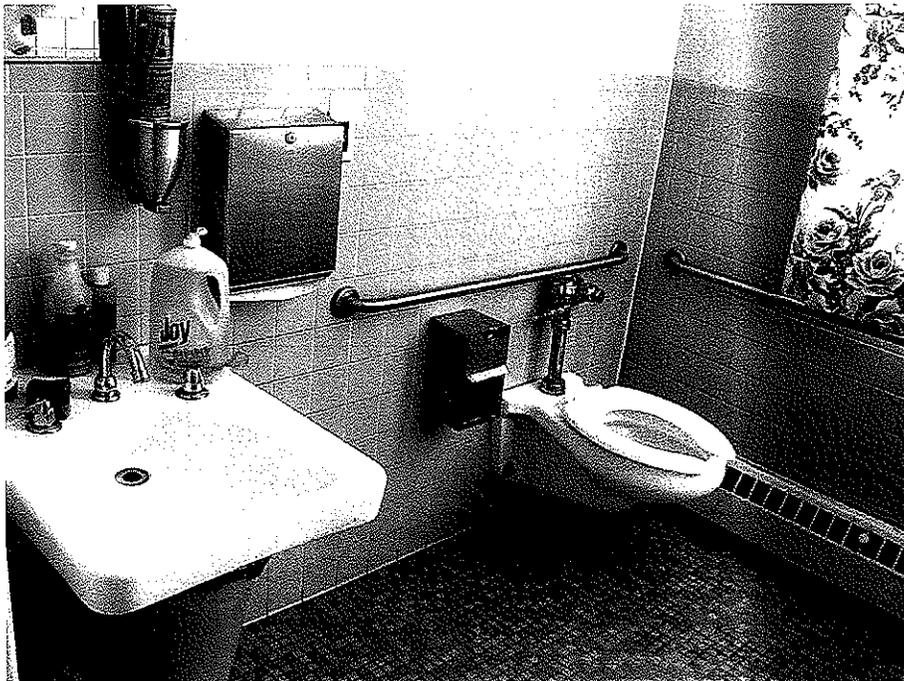
FIRST FLOOR MEN'S ROOM

- Non-Accessible / Compliant Toilet Accessories

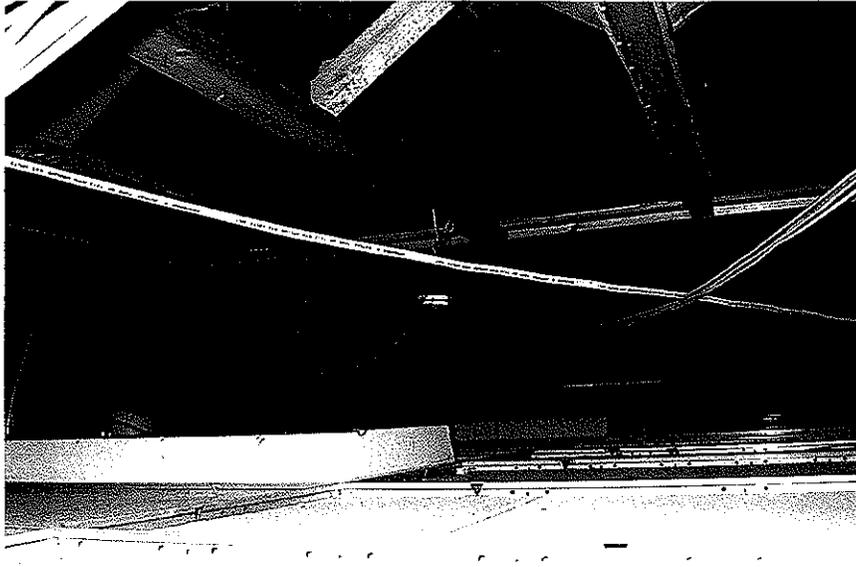
FIRST FLOOR MEETING ROOM CEILING PLENUM

- Previously Installed Suspended Ceiling / Lighting
- Remaining Furring from Original Ceiling Finish
- Original Column Capital Concealed Above Ceiling
- Loose Electrical Wiring
- Plenum Smoke Detector

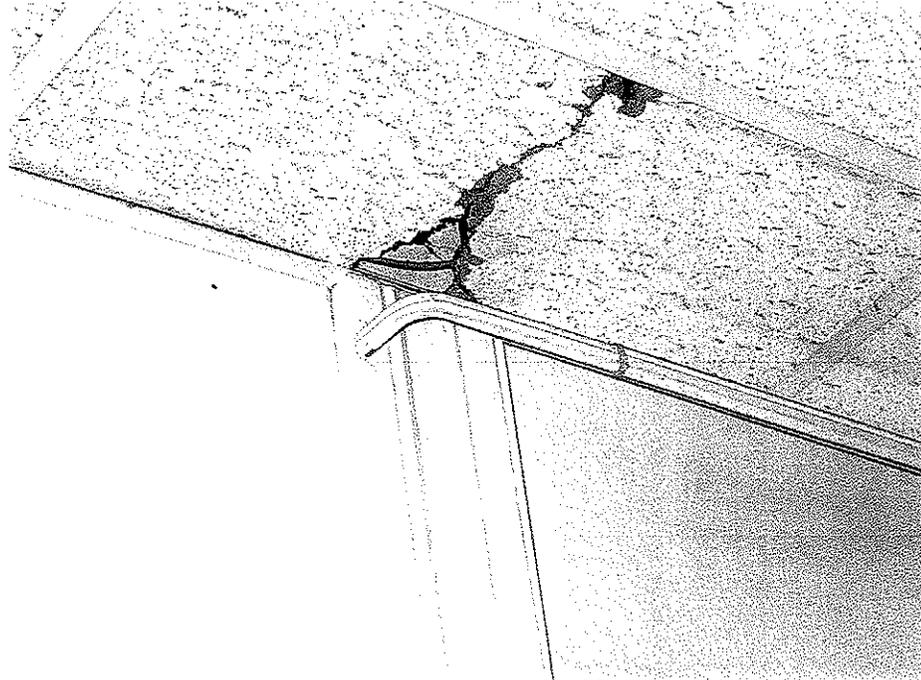
FIRST FLOOR MEETING ROOM WINDOW HEAD

- Wood Window Trim at Suspended Ceiling
- Suspended Ceiling Bisects Glass Window

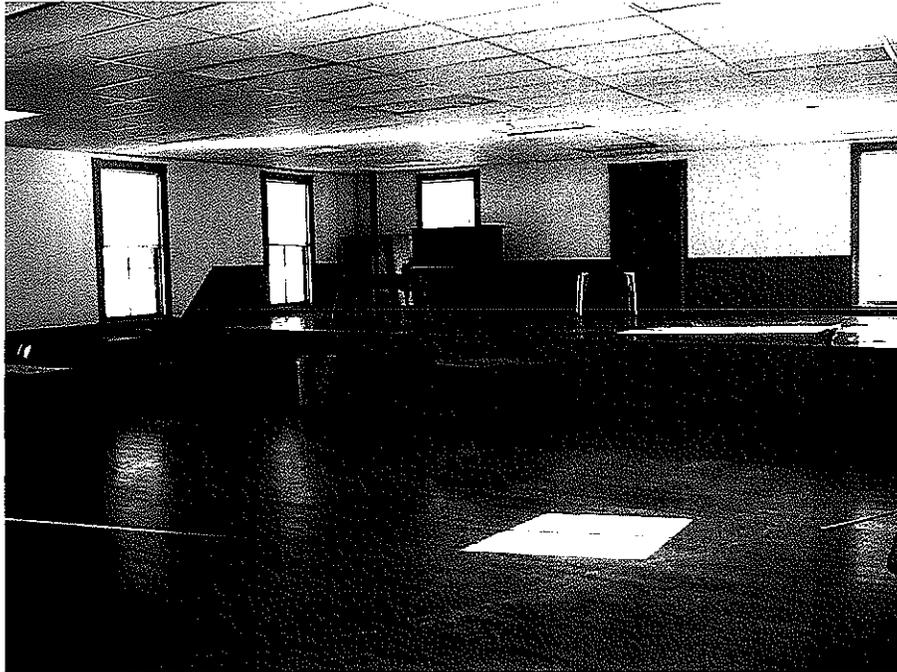
SECOND FLOOR MEETING ROOM / STAGE

- Previous Installed Suspended Ceiling / Lighting
- Low Window Sill Height at Stage

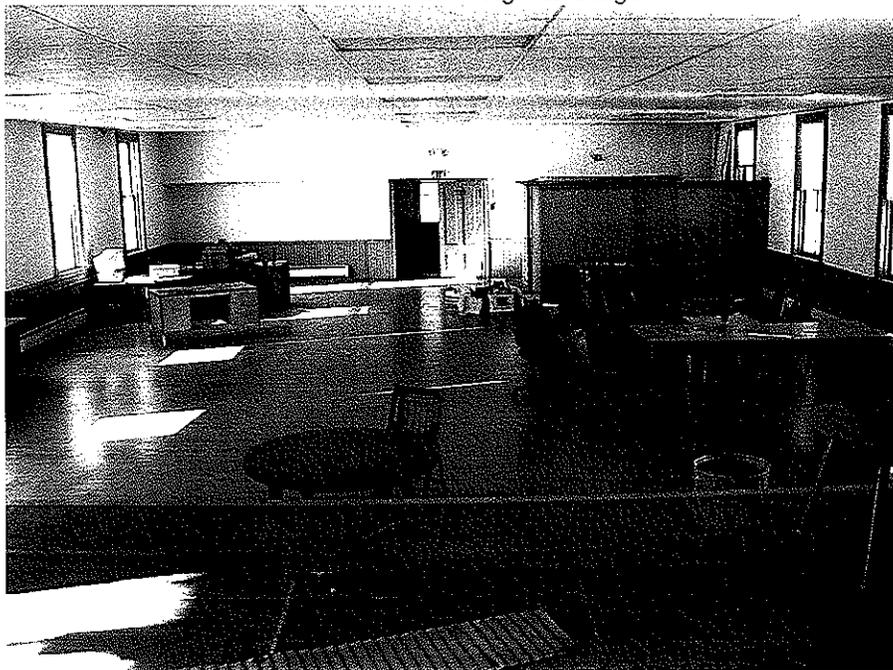
SECOND FLOOR MEETING ROOM / STAGE

- Previous Installed Suspended Ceiling / Lighting
- Temporary Wood Partitioning
- Previously Installed Perimeter Hydronic Baseboard

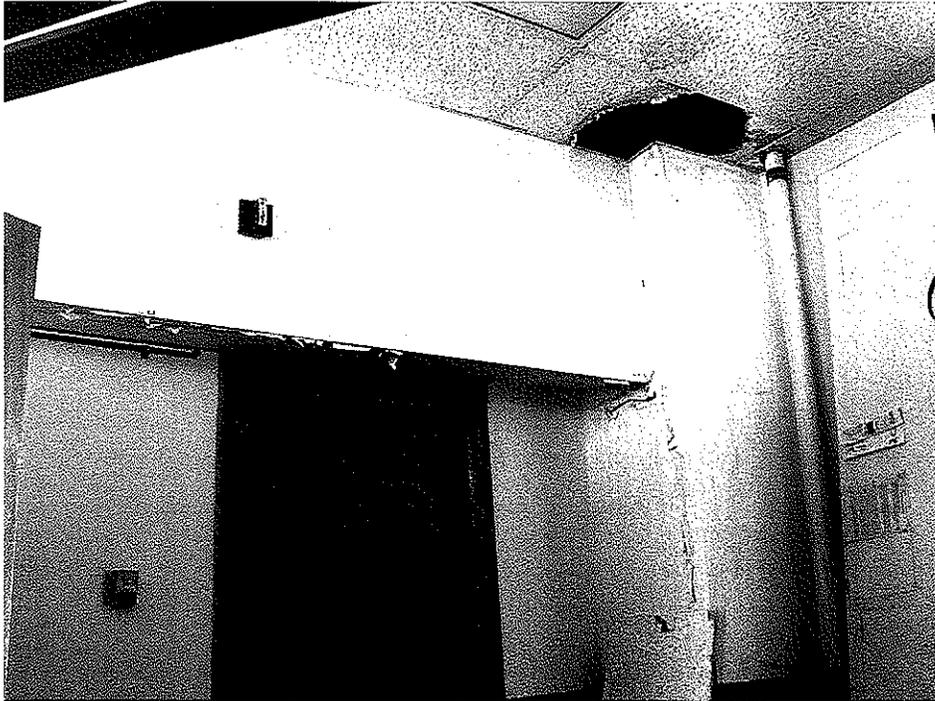
SECOND FLOOR MEETING ROOM

- Previous Water Damage Near Chimney

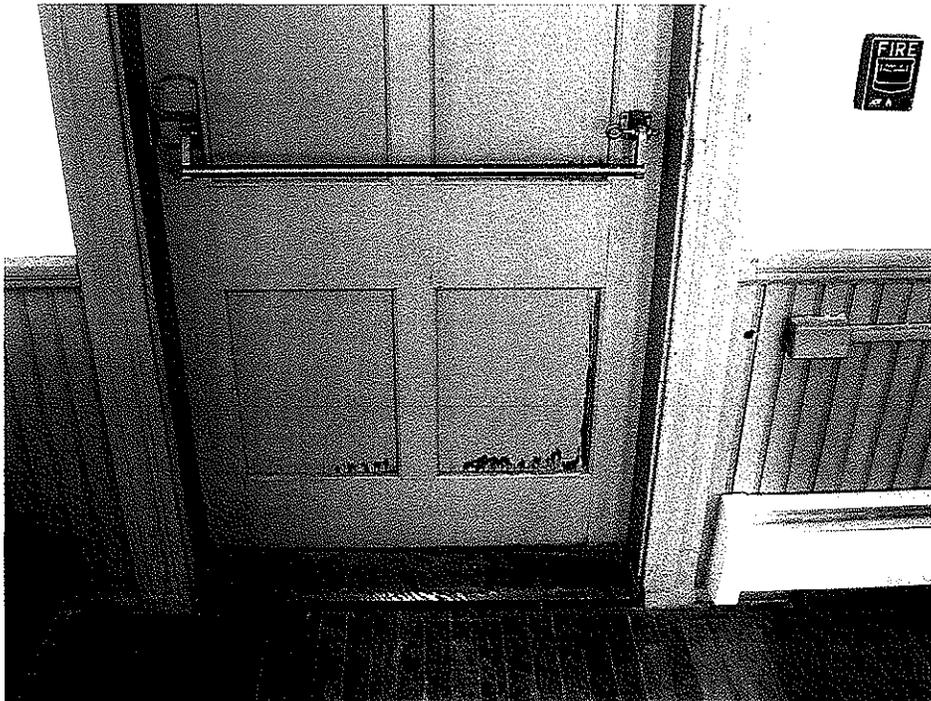
SECOND FLOOR FIRE ESCAPE EXIT DOOR

- Moisture Damage at Lower Door
- Wood Wainscoting
- Previously Installed Hydronic Baseboard

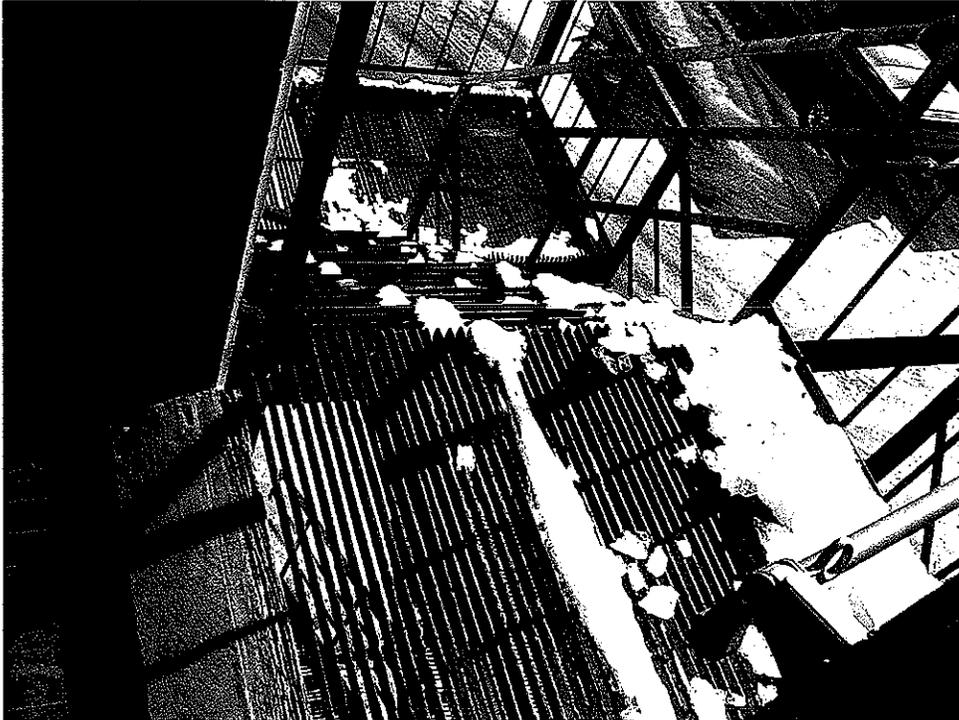
SECOND FLOOR FIRE ESCAPE

- Snow and Ice Falls from Roof Obstructing Exit
- Wood Will Partially Rotted

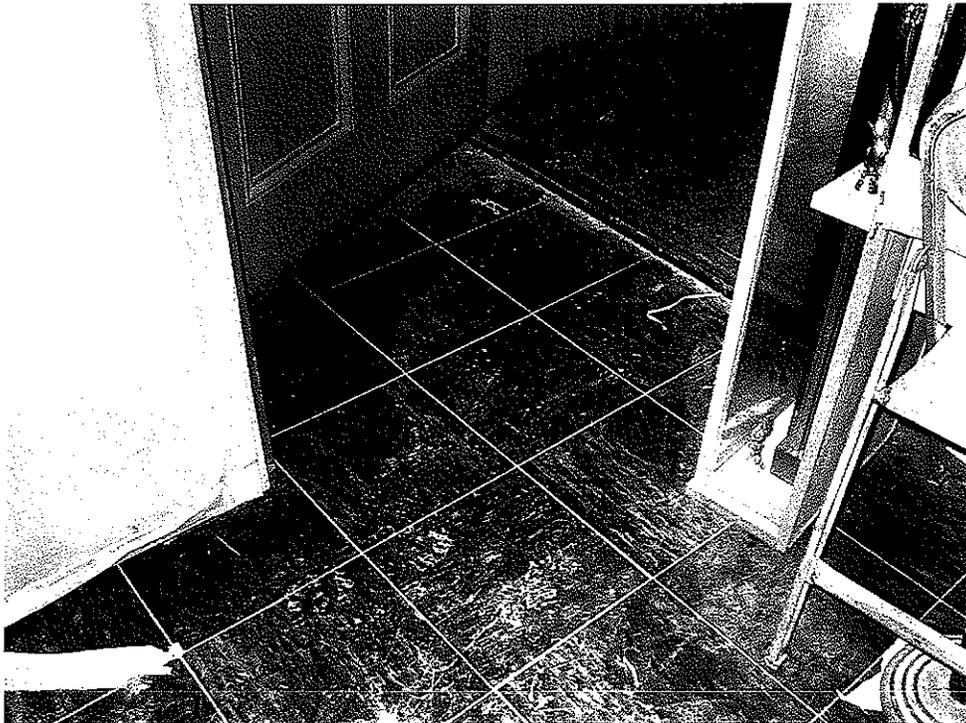
SECOND FLOOR OFFICE

- Probable Vinyl Asbestos Floor Tile

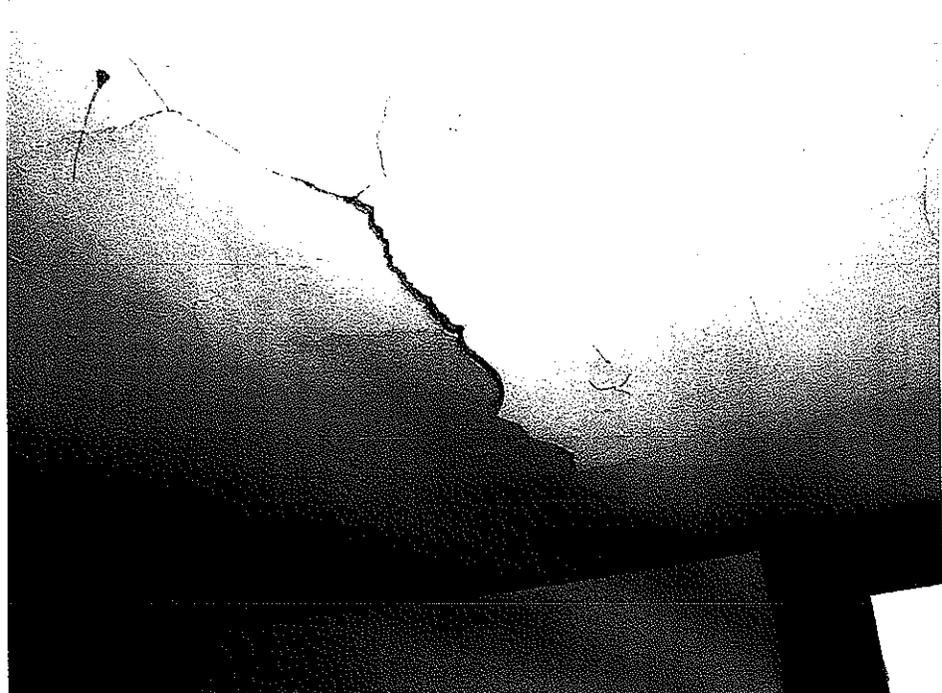
SECOND FLOOR LOBBY CEILING

- Cracked Plaster

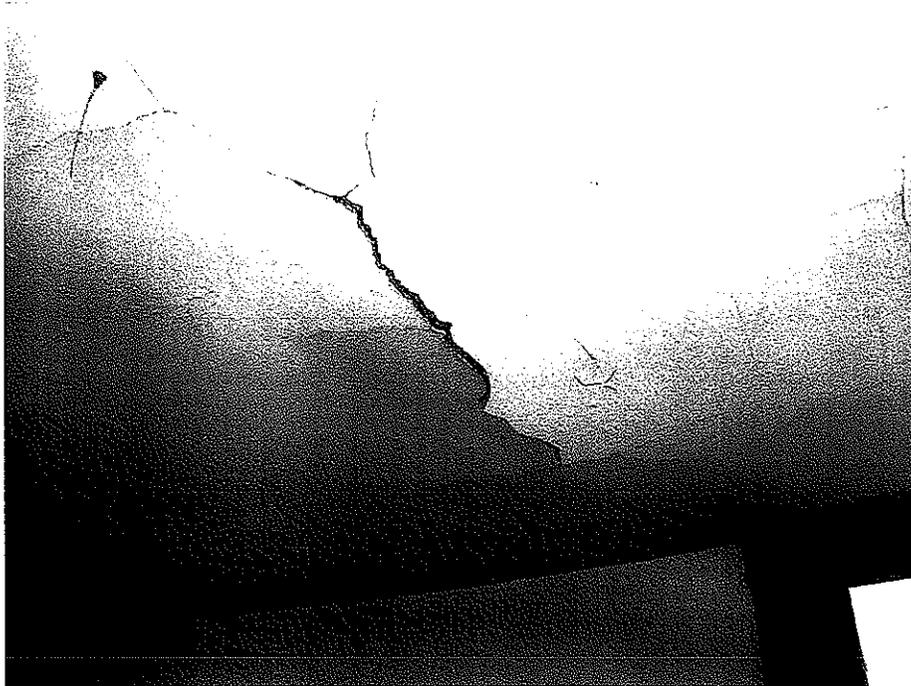
SECOND FLOOR LOBBY CEILING

Cracked Plaster

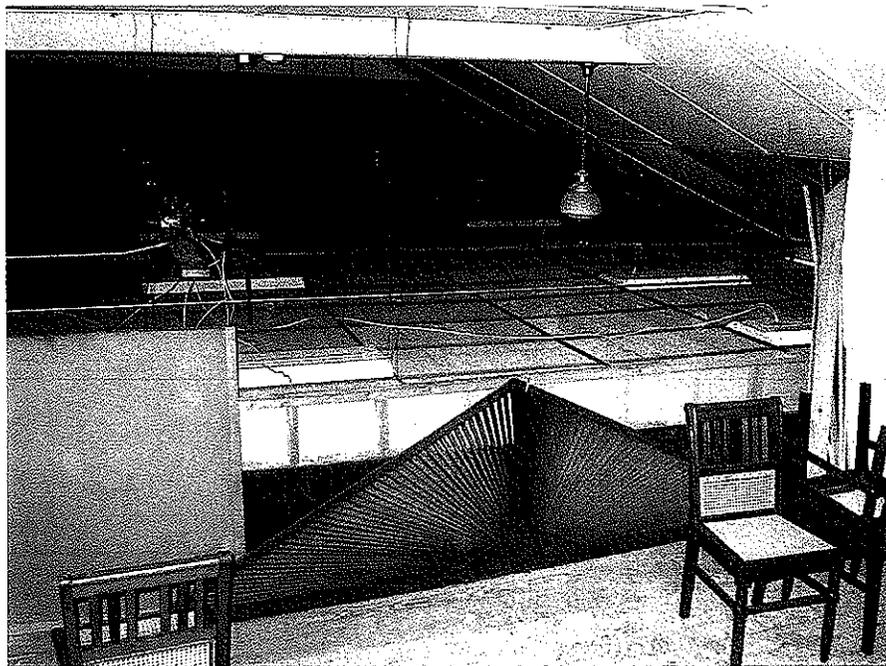
BALCONY

- Original Ceiling Above Suspended Ceiling
 - Original Type Light Fixtures
- Timber Truss Tie Rod and Cable Repairs

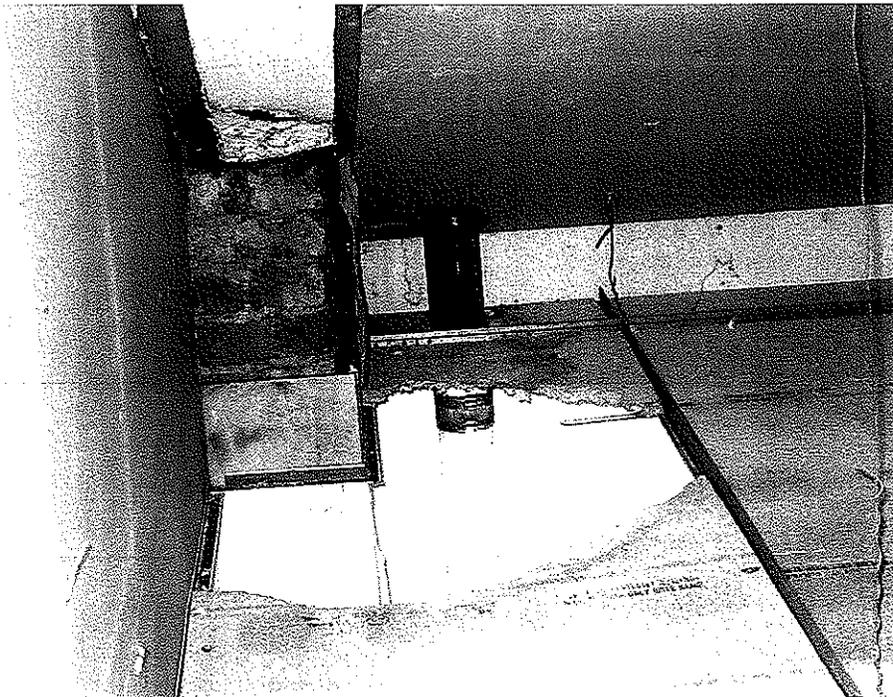
BALCONY

- Previous Roof Leak / Damage Near Chimney
