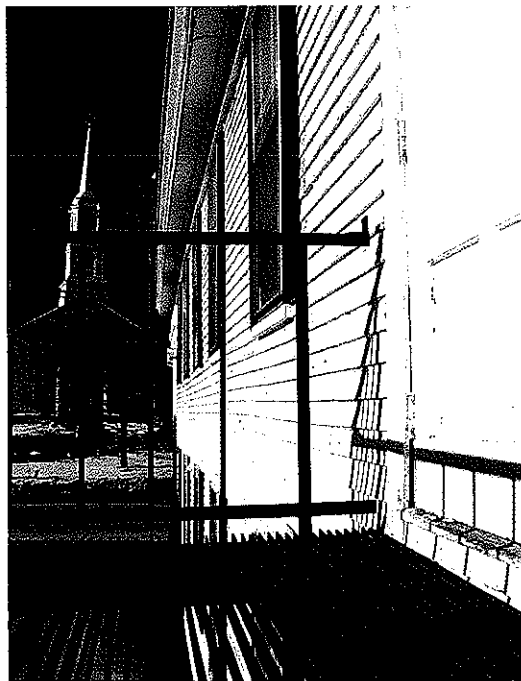
Inadequate anchorage of Railing

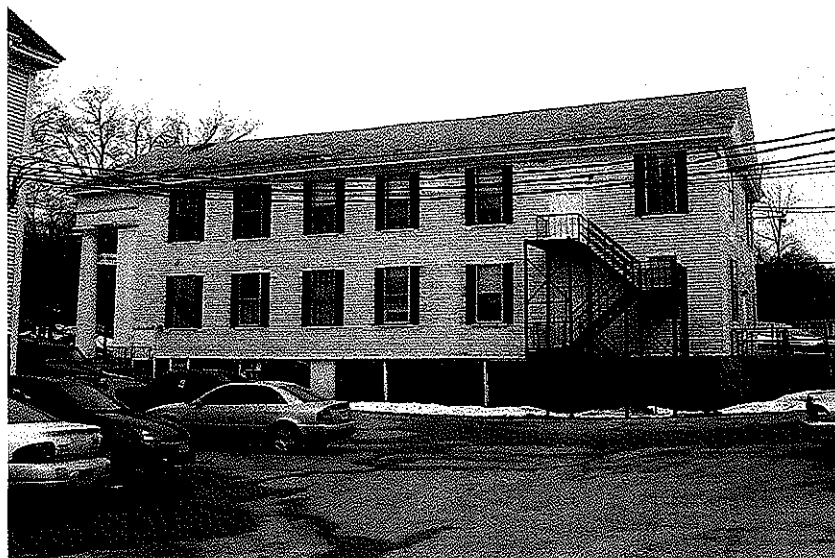
Right Side Building Elevation – Hump in Roof Ridge

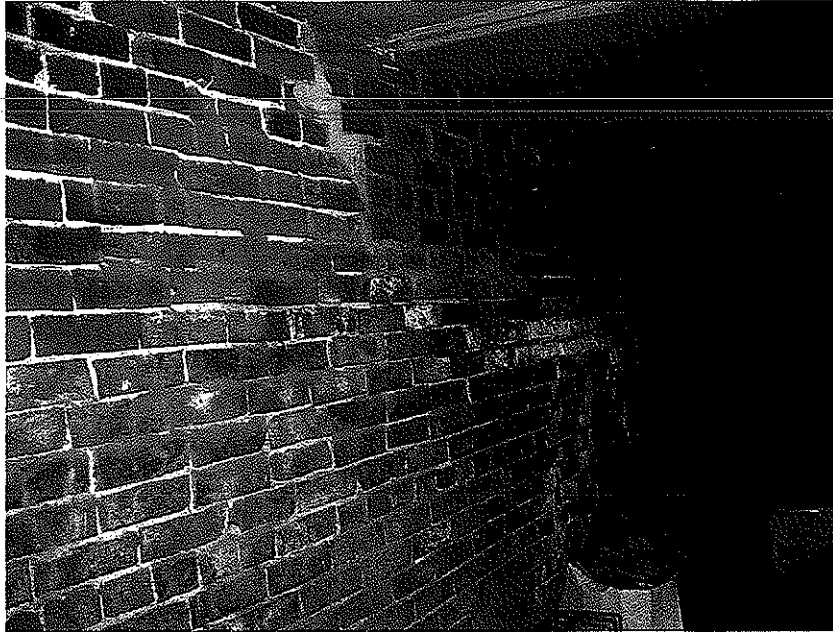
Interior brick wall requiring re-pointing
