**Town of Sterling  
Council-On-Aging  
Feasibility Study for potential  
Senior Center Properties**  
1 June 2007

## Executive Summary

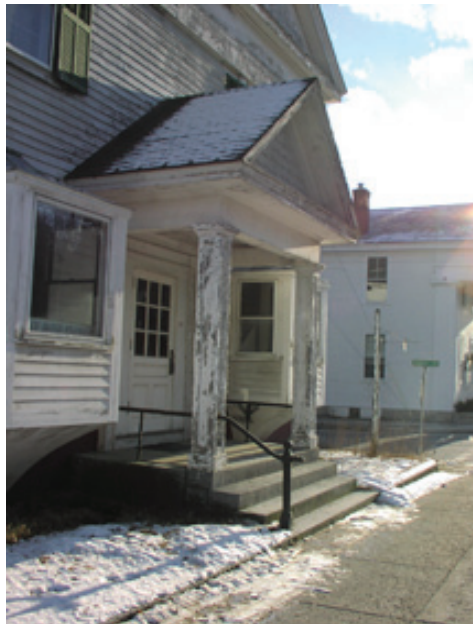
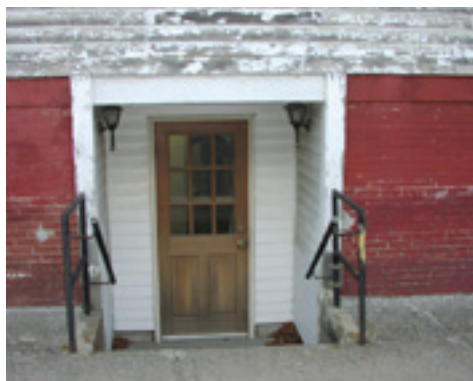
The building is currently inaccessible and not in conformance with many of the Massachusetts Architectural Access Board regulations 521 CMR. In its renovation to be used as a Senior Center, it will be required to meet all of the requirements without exception due to the breadth of the work to be undertaken in the renovation. Generally these requirements will include entrance and egress, accessible stairs, doors, toilet rooms, passage clearances, and elevator.

The site is relatively flat, yet the grade change around the building and leading to the front door is higher than the maximum 5% required for accessible sidewalks and grounds. This is inherent to the natural grade of site.

*top: existing rear entry  
middle: existing front entry  
bottom: existing side entry*

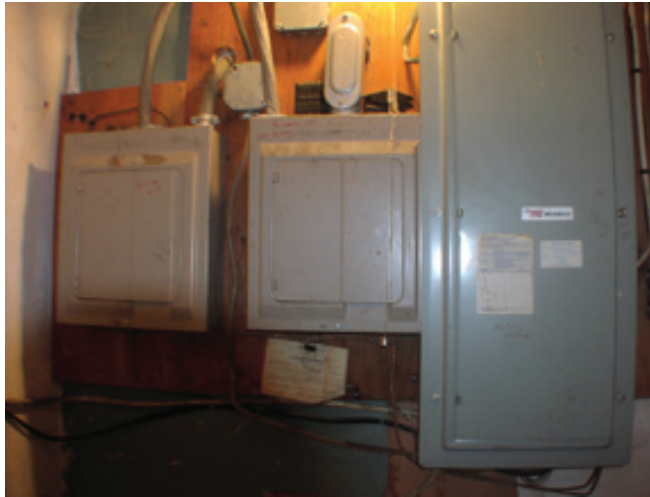
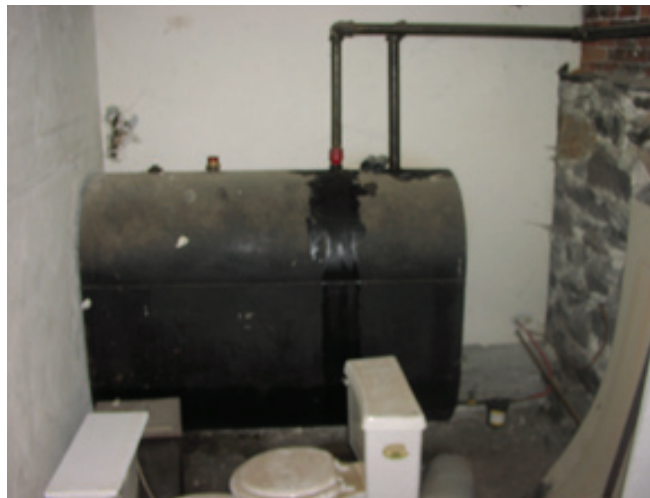
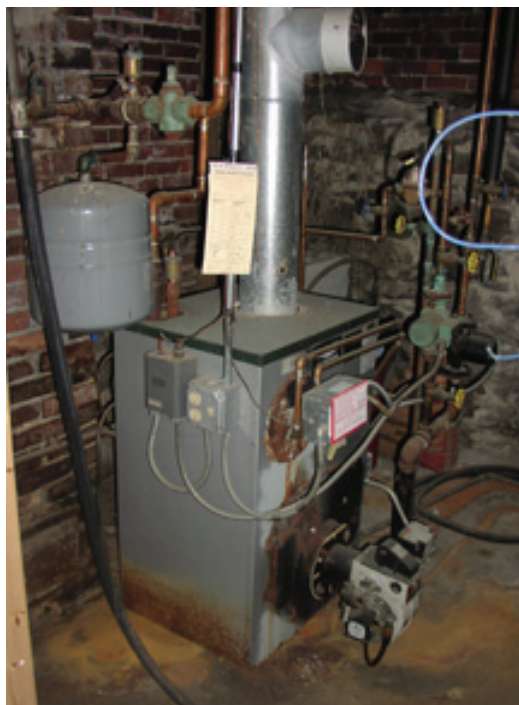
The electrical system for the building is a series of breaker panels located at the rear of the basement level. The system has additional sub-panels distributing the electricity through out the rest of the building. The 200 amp service is not adequate for the future needs of the building, especially the power requirements of an elevator.

The public water service enters the building off of Main Street in the basement. The service is distributed through out the building to non- accessible toilet rooms on the various floors. Hot water is drawn from the Boiler.

Heating and ventilating and air conditioning systems in the building are also in working order and of fair to good condition. They are all separate systems for separate uses and floors. The second floor toilet rooms have electric heat. The remainder of the building is on forced hot water baseboard delivery units. The toilet room ventilation is by ducted fan, relying on ambient air for changes. There are some through wall independent air conditioning units on the first and second floors.

*top: Basement Electrical Panel - subpanels throughout*  
*middle: Oil - Fuel Storage*  
*bottom: Oil - Fuel Boiler*

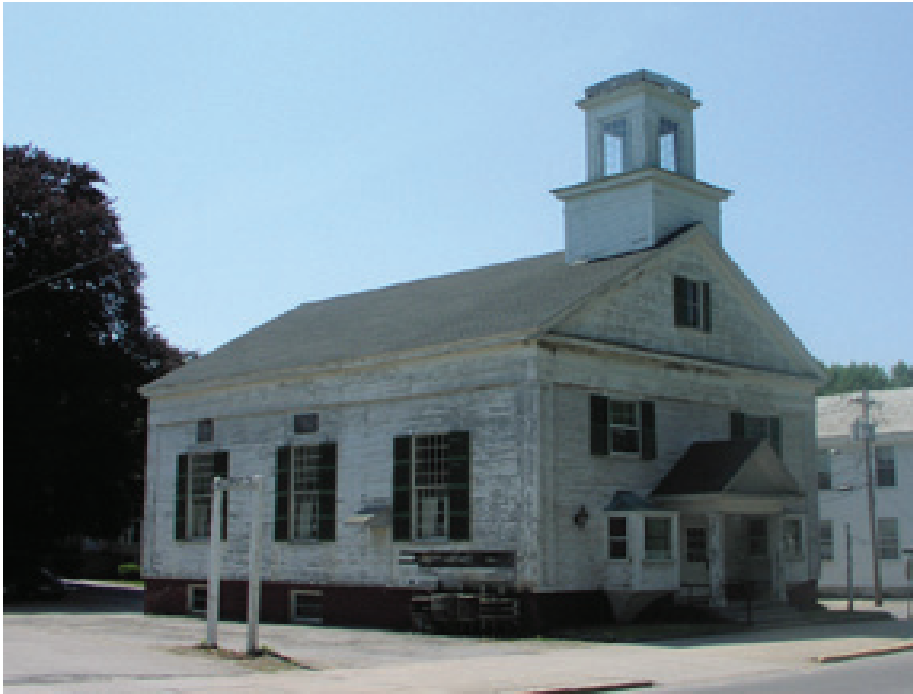
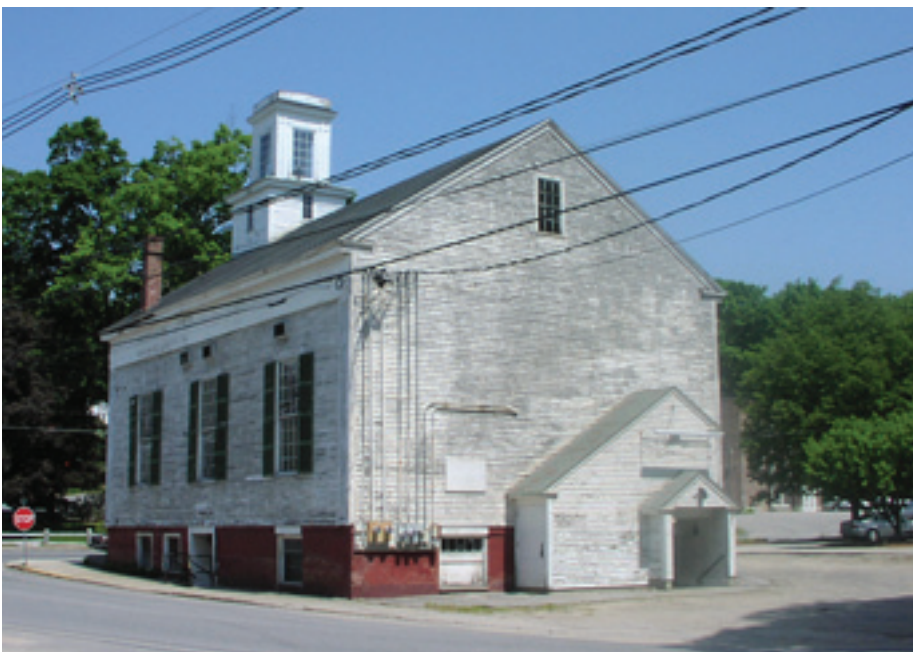
The asphalt roof appears to be in fair to good condition and is approximately 10 years old. When installed, a layer of plywood was installed over the existing sheathing to shore up and provide a continuous nailing surface. There are no obvious signs on the interior that there are any roof issues from leaking or from condensation. It should be considered that the roof is in the mid life point and will need replacement within or around 15 years.

The exterior siding and trim detail is mostly original and in fair condition. It needs to be refastened over 80%, re-sealed (caulked) and prepped and painted. Note that removal of paint is likely hazardous waste. Approximately 20% of the clapboards need to be replaced. It is possible that the sheathing boards under the clapboards are in some compromised condition and will require replacement over 20% of the exterior.

The existing windows and doors are in fair to poor condition. The attic and in between floors are adequately insulated for current conditions. It is not clear if the building is insulated in the walls, it is probable that there is no air barrier installed behind the finish siding.

*top: Northeast corner showing front facade and east elevation  
bottom: Southwest corner showing rear facade and west elevation*

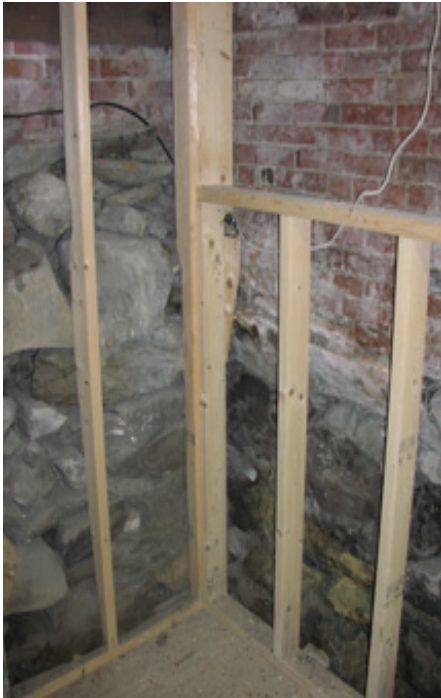
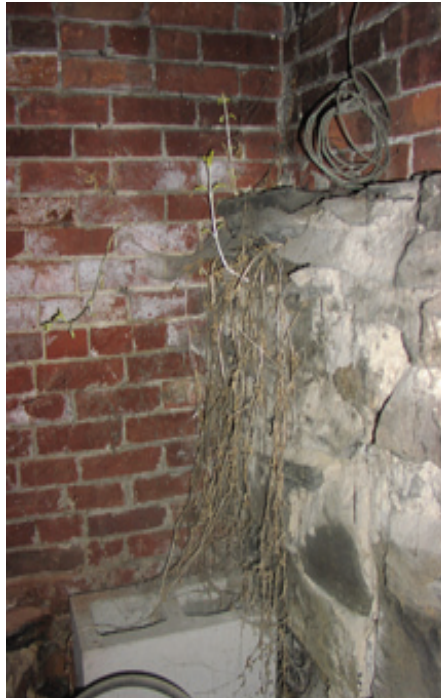
Foundation - Stone & Brick - note mortar missing on right photo

The perimeter foundation is made up from loose laid field stone approximately 4 feet above the floor level. There does not appear to be any mortar holding the stones together in some of the areas exposed to view. The top 4-5 feet of the foundation is comprised of 3 or 4 courses of brick and mortar providing a level base for the supporting perimeter walls. It appears that the foundation is not supporting much of the first floor loads, but supports the second floor the attic and the roof loads.

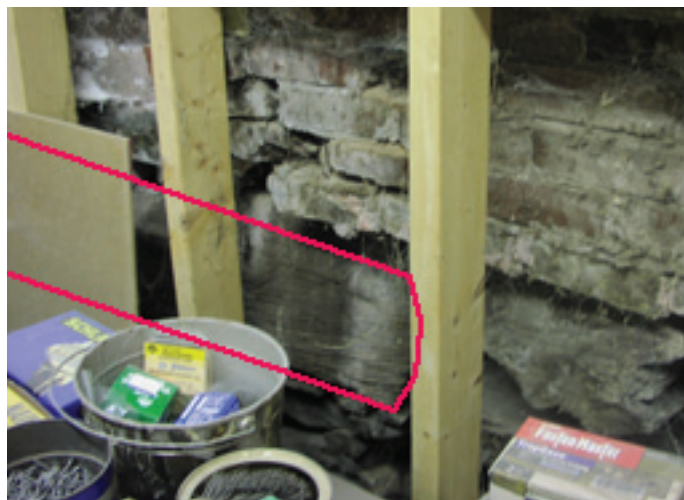
Wood Timber in Stone Foundation - needs review

There is a wood timber encased in the field stone foundation 1/3 down from the NE corner. This is unusual and should be removed and replaced with masonry materials.

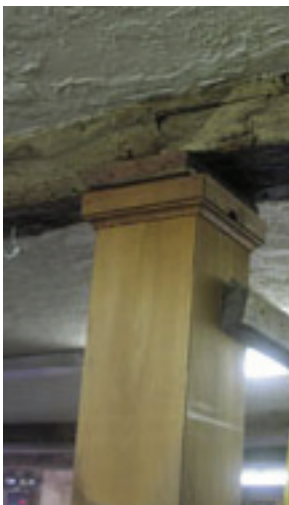
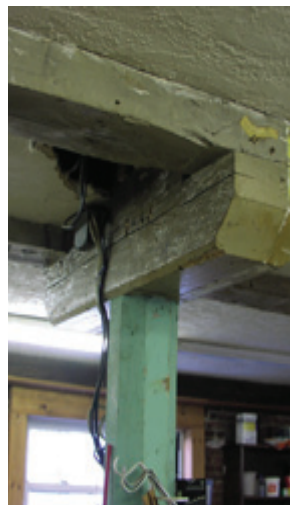
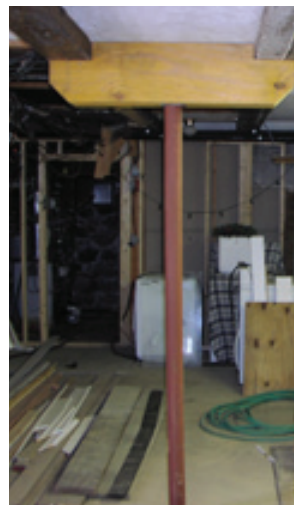
Various Basement Columns

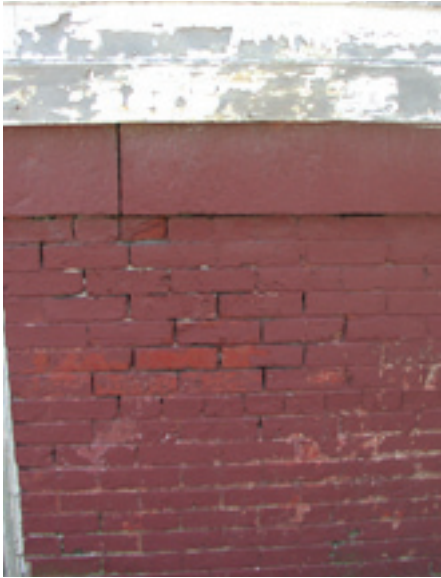
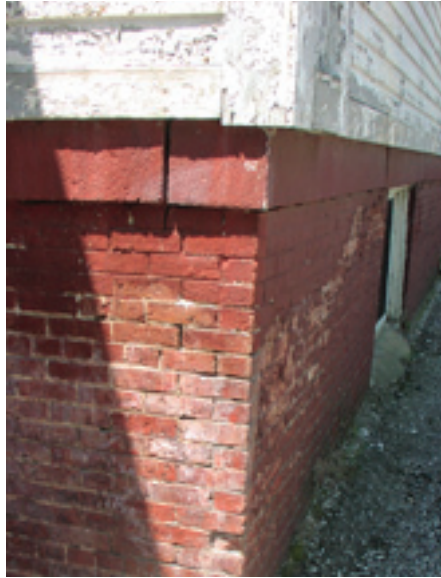
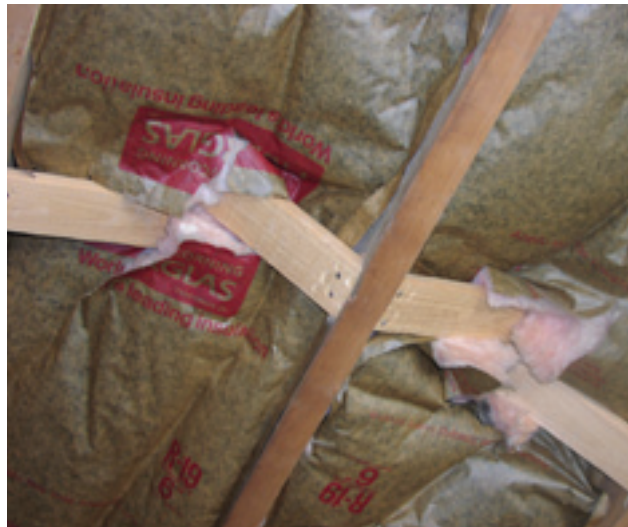
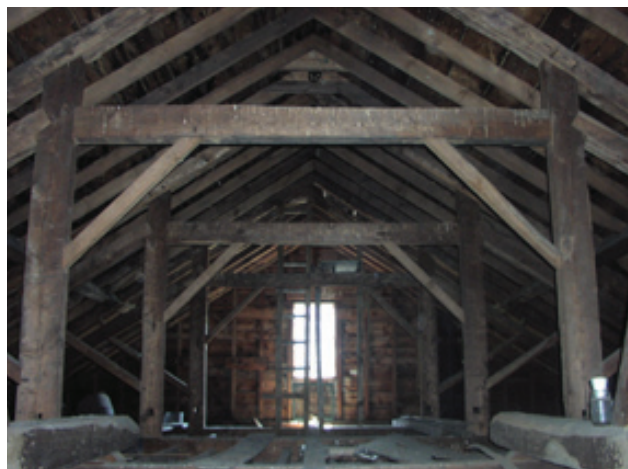
*top: perimeter foundation - exterior re-pointing required  
middle: second floor conventional framing  
bottom: Attic post and beam framing*

Our observations are limited to visible defects and it is recommended that the structural integrity of the entire frame and foundation system be reviewed by a structural engineer if the proposal to adaptively reuse this building goes forward beyond this report. A Chapter 34 of 780 CMR report by a Licensed Structural Engineer (PE) is also required for the repair, alteration, addition, and change of use of the existing building (not part of this report).

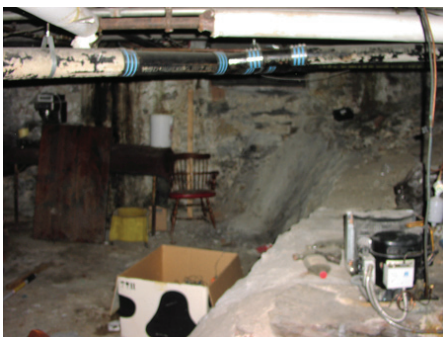
the basement (west to east) terminating at a stair that ends behind the building under the main first floor stair. A couple concrete footings were noticed to have some small cracking and deterioration around the footings but no other deterioration has been detected. The basement under the existing bar area is two smaller rooms – one containing the maintenance room and another for storage. The rooms have more headroom. Due to the amount of materials in these rooms, wall and foundation conditions could not be inspected. The storage area under the shorter arm of the "L" also contains ledge and conditions here were also not fully inspected as doors were locked. No mildew or mold was observed in the basement and no damp scent was present.

*above: basement ledge conditions*

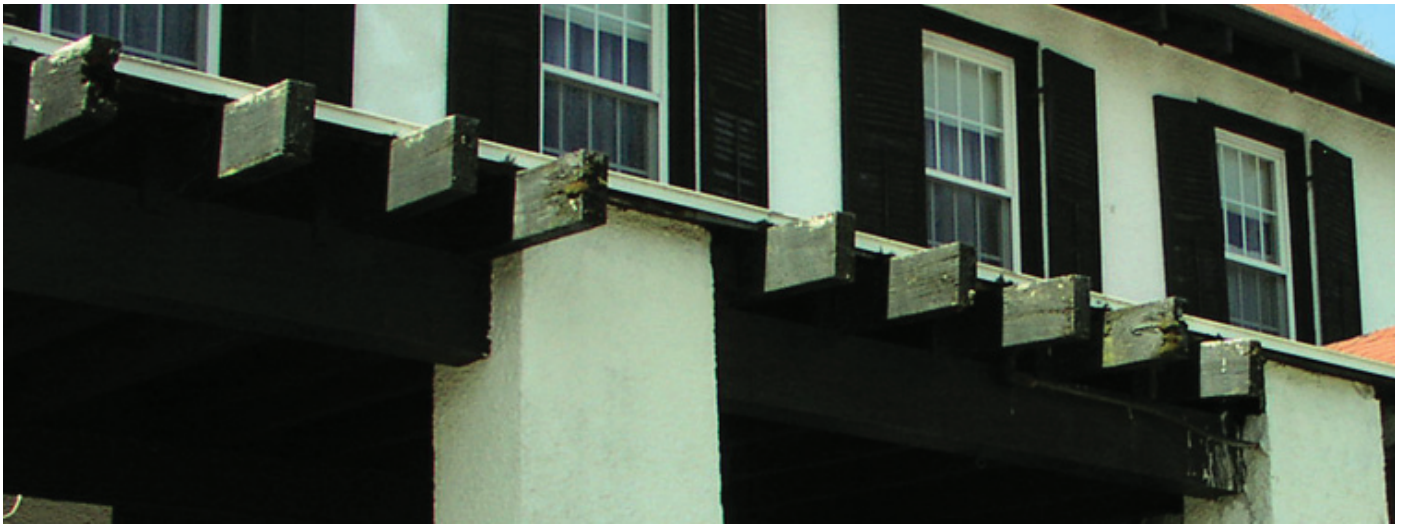
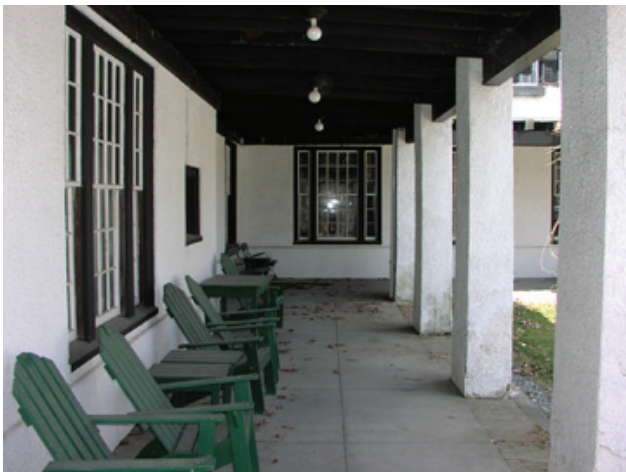
Small amounts of mold and dirt cover the lower portion of the porch columns and exterior wall. Minor cracking and openings can be observed in on the skin over the entire building. The stucco has been painted in the past and will require painting in the near future. Flaking and exposed stucco is observed across the exterior but especially on the eastern and western building ends particularly above the first floor.

Porch beams supporting the porch roof have exposed ends which show significant deterioration. The beams show no sign of structural failure and may be fixed by removing the exposed and deteriorating sections.

*top: deteriorating exposed beam ends  
left: typical exterior conditions under porch  
bottom, left: rear deck  
bottom, right: typical exposed exterior  
bottom: deteriorating column bases*
