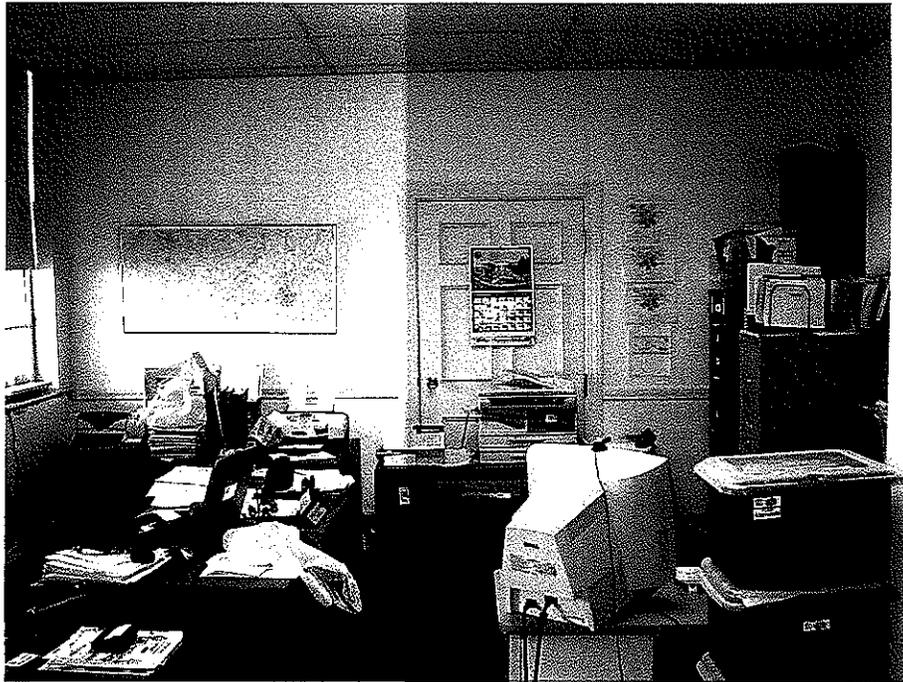
FIRST FLOOR OFFICE

- Previous Newer Finishes Include Gypsum Wallboard, Suspended Ceiling, Lighting, Chairrail, Door, Carpeting

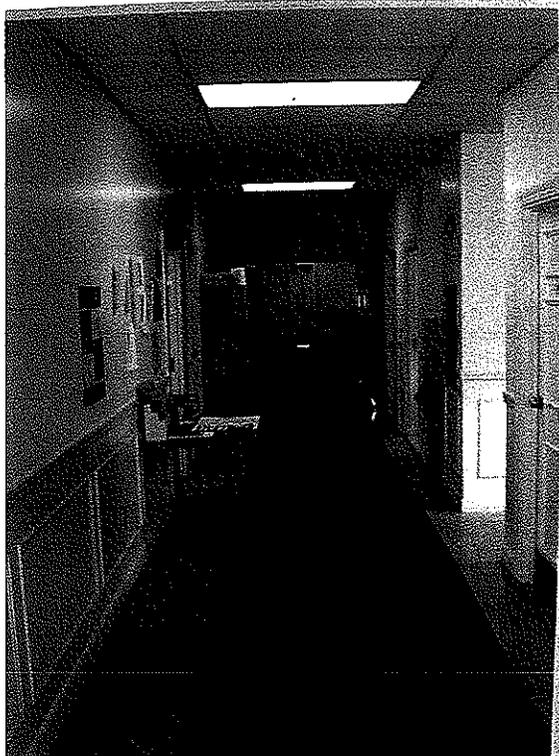
FIRST FLOOR CORRIDOR

- Previous New Finishes Include Gypsum Wallboard, Suspended Ceiling Lighting, Wainscoting, Doors, Vinyl Tile Flooring

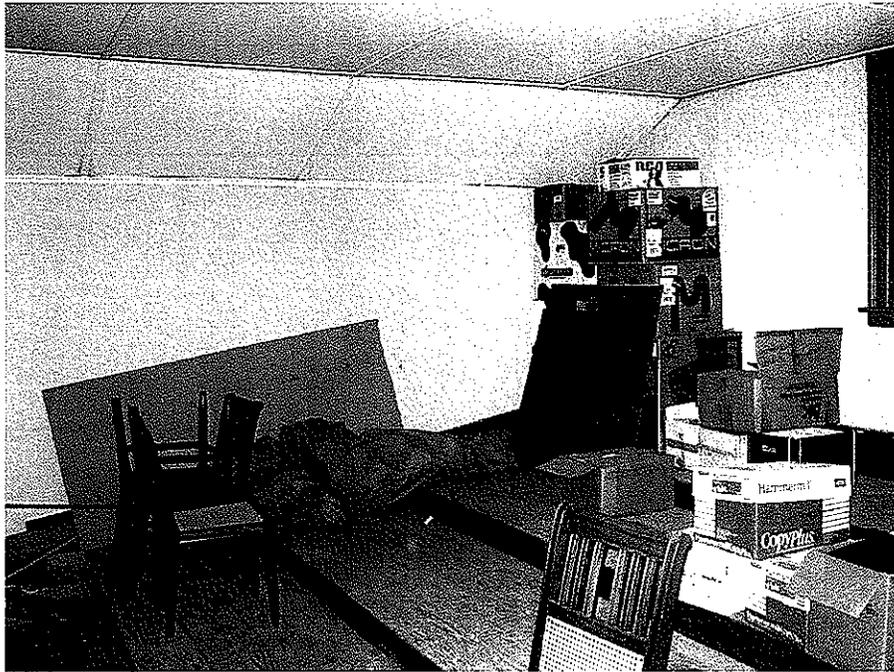
BALCONY

- Board and Batten Ceiling
- Original Stepped / Tiered Floor
